SUSTAINABLE TREE MANAGEMENT

PRELIMINARY TREE ASSESSMENT

Site Address:
Collison Estate, Cranbourne East

Prepared June 2018
Updated 17 May 2019

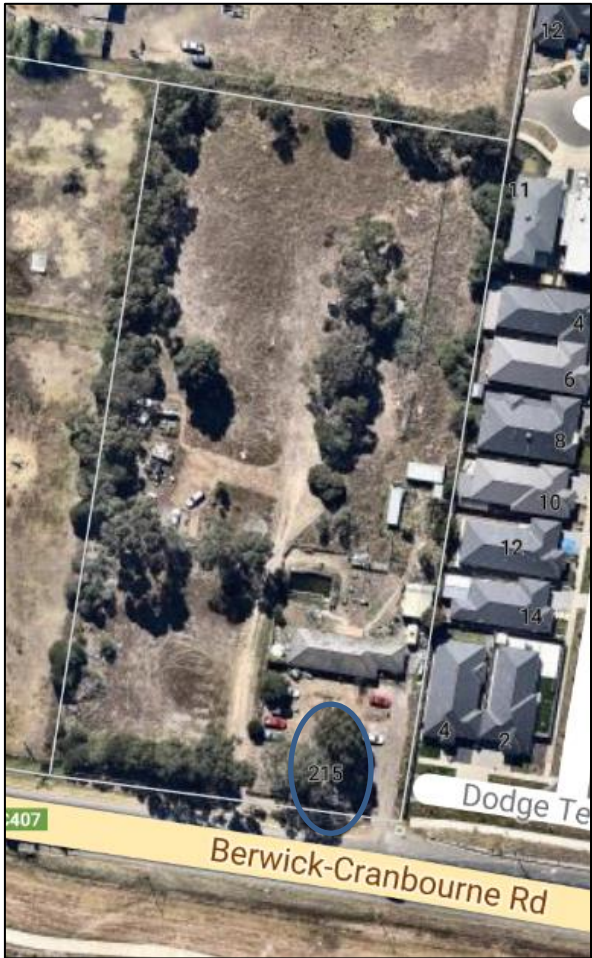
215 BERWICK CRANBOURNE ROAD, CRANBOURNE EAST

Site Description- The existing dwelling is situated along the eastern boundary towards Berwick Cranbourne Road. The larger trees on site are growing adjacent to Berwick Cranbourne Road. These trees are a mix of Eucalypt plantings most likely planted as a screen and noise buffer. No remnant vegetation was observed during the inspection.	
Species observed on site	Majority native
Approx. age of trees on site	Semi mature and mature
Approx. tree heights	13 metres
Significant trees	No
Any habitat hollows observed	No
Is further targeted assessment required on this site.	Yes - River Red Gum growing within front setback. (Location highlighted in blue)

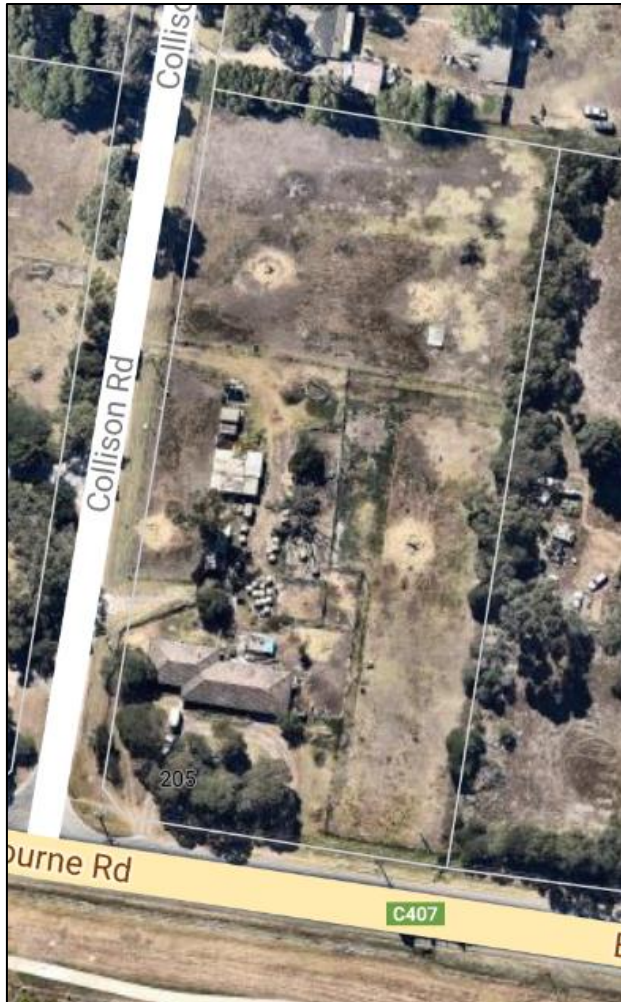
Site Description- The majority of land is currently being use for horse agistment and hobby farming purposes. Semi mature native trees are growing on the corner of Collison Road and Berwick Cranbourne Road. All trees on the site have been assessed as planted vegetation and no remnant vegetation was observed. Tree observed within the rear yard are in poor overall health and condition.

Species observed on site	<i>E. saligna</i> , <i>E nicholii</i>
Approx. age of larger trees on site	Semi mature
Approx. tree heights	13 metres
Significant trees	No
Any habitat hollows observed	No
Is further targeted assessment required on this site.	No

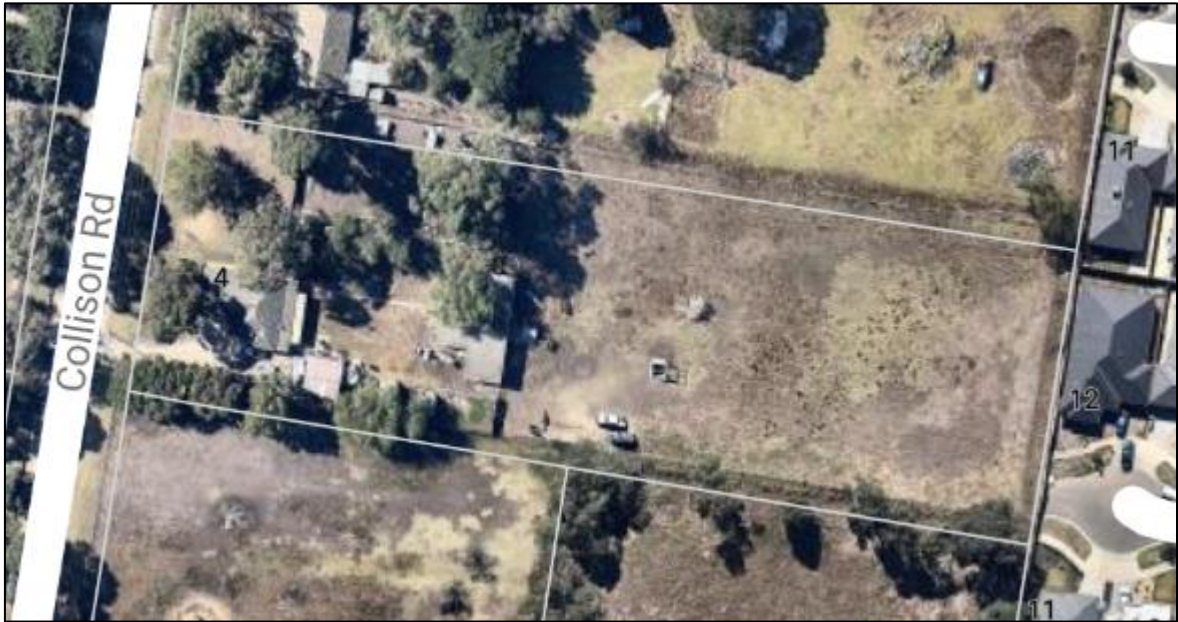
4 COLLISON ROAD, CRANBOURNE EAST

Site Description- Majority of land is being used as a hobby farm. Trees growing along the southern boundary are planted <i>Melaleuca armillaris</i> . Other semi mature native and exotic trees were observed and are consistent with planted vegetation. No remnant trees were observed.	
Species observed on site	Eucalyptus. sp
Approx. age of larger trees on site	Semi mature
Approx. tree heights	12 metres
Significant trees	No
Any habitat hollows observed	No
Is further targeted assessment required on this site.	No

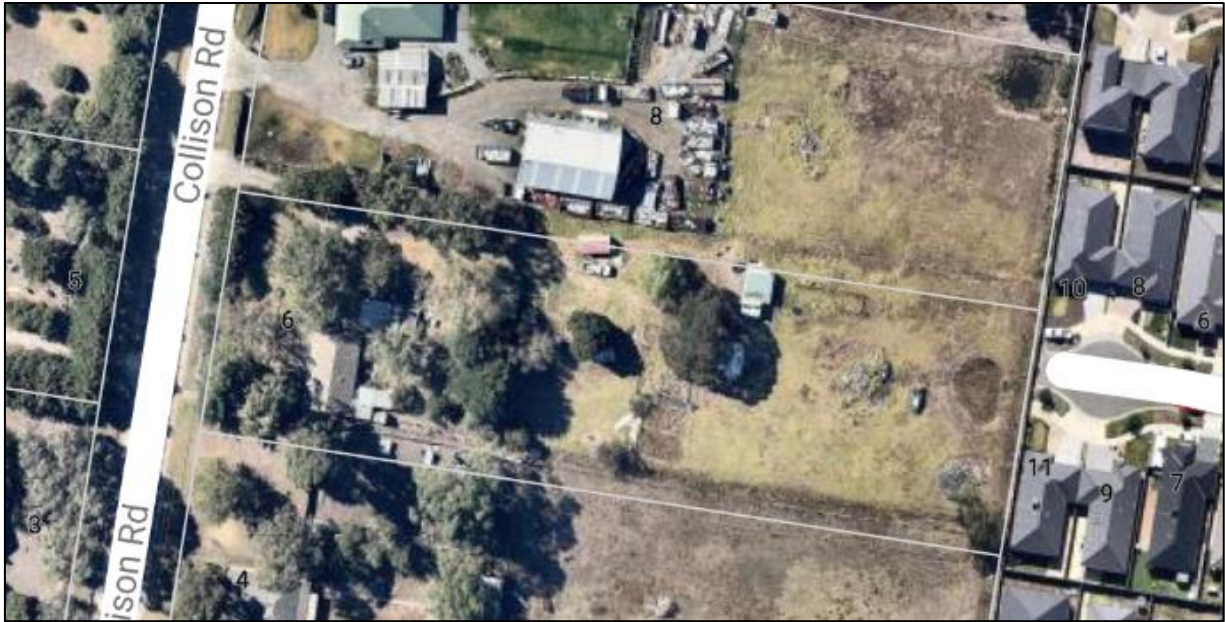
Site Description- Most of the vegetation observed are exotic specimens including Ash and Cypress. Overall the native vegetation observed on site is in poor health and condition.	
Species observed on site	Native and exotic
Approx. age of larger trees on site	Semi mature
Approx. tree heights	14 metres
Significant trees	No
Any habitat hollows observed	No
Is further targeted assessment required on this site	No

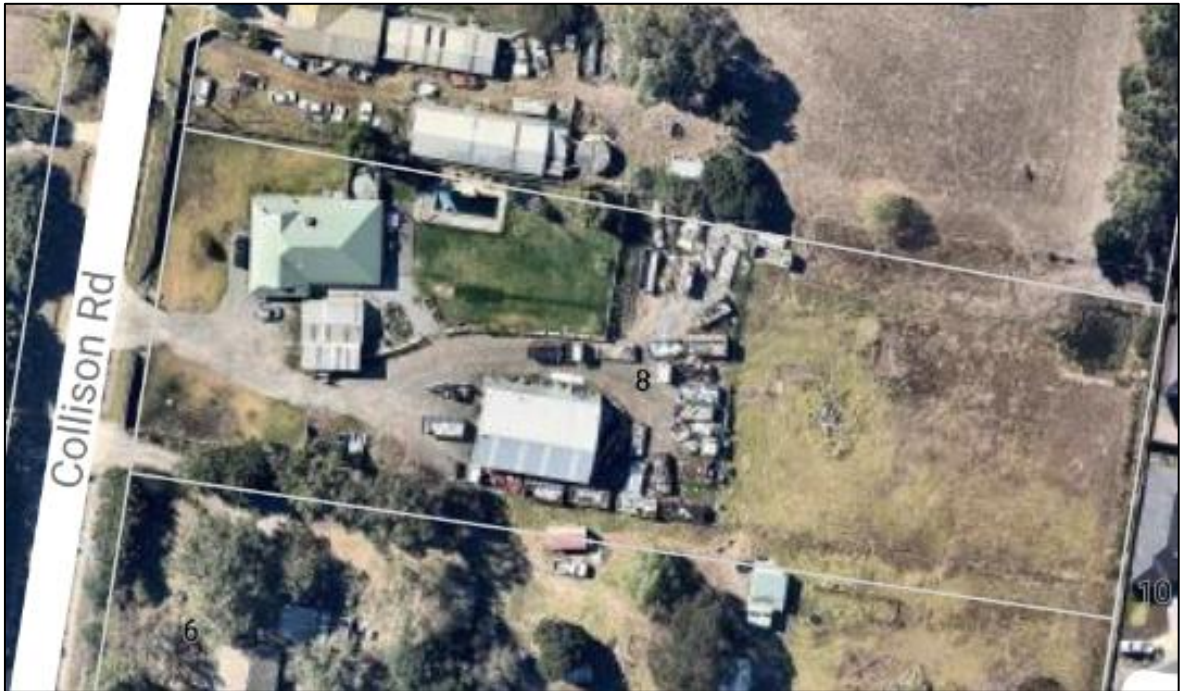
Site Description- Majority of land is clear of vegetation. No significant native or remnant vegetation was observed.	
Species observed on site	Native
Approx. age of larger trees on site	Semi mature
Approx. tree heights	5 metres
Significant trees	No
Any habitat hollows observed	No
Is further targeted assessment required on this site	No

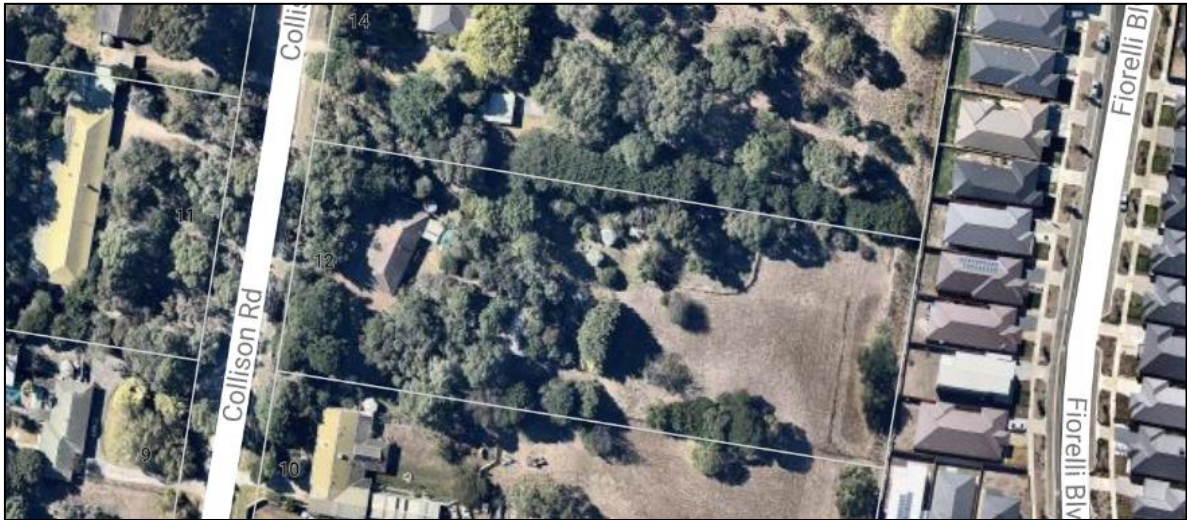
Site Description- Dense mature plantings of exotic specimens within the front setback of the property. These trees are Cypress and Pine species. No remnant native vegetation was observed.	
Species observed on site	Exotic
Approx. age of larger trees on site	10 plus
Approx. tree heights	10 metres
Significant trees	No
Any habitat hollows observed	No
Is further targeted assessment required on this site	No

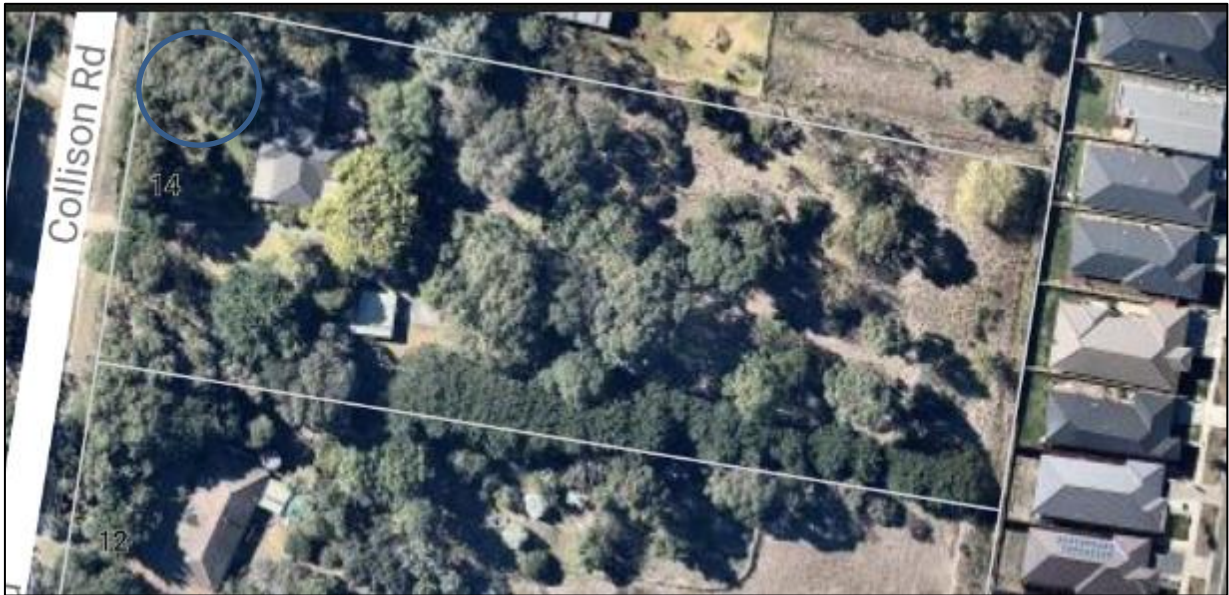
Site Description- Dense vegetation plantings especially growing along the southern boundary. No remnant vegetation observed from road side however there is a mature <i>Eucalyptus viminalis</i> growing in the front setback that requires a targeted assessment.	
Species observed on site	Native and exotic
Approx. age of larger trees on site	30 plus
Approx. tree heights	14 metres
Significant trees	No
Any habitat hollows observed	No
Is further targeted assessment required on this site	Yes

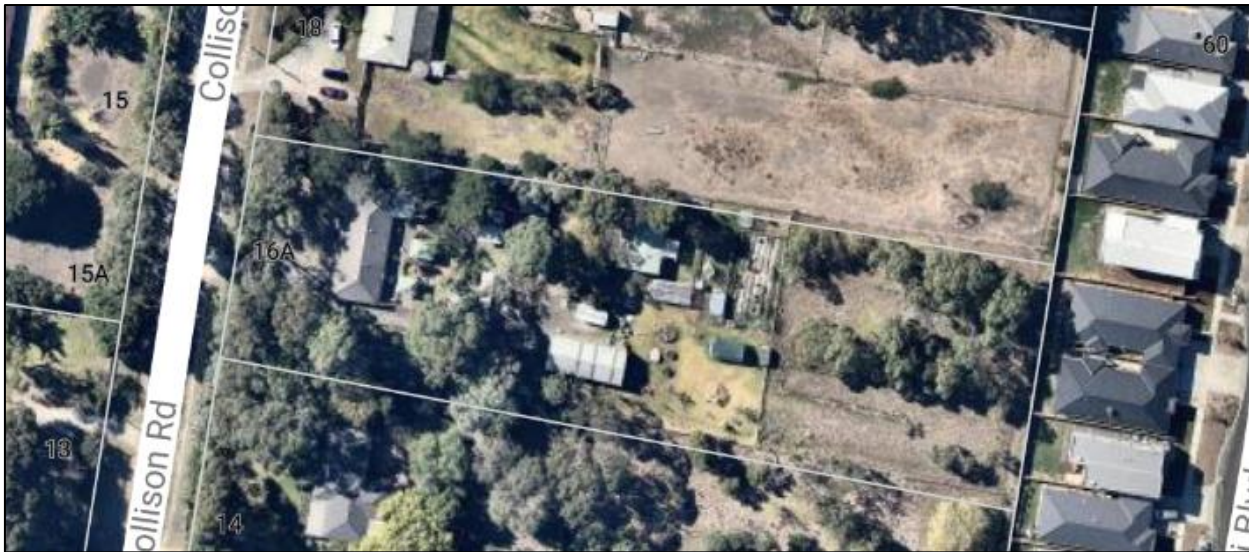
Site Description- Dense plantings within the front setback of the property. Trees have been likely planted as a wind breaks or screening around boundaries.	
Species observed on site	Mix of exotic and native
Approx. age of larger trees on site	30 years
Approx. tree heights	12 plus
Significant trees	No
Any habitat hollows observed	No
Is further targeted assessment required on this site	No

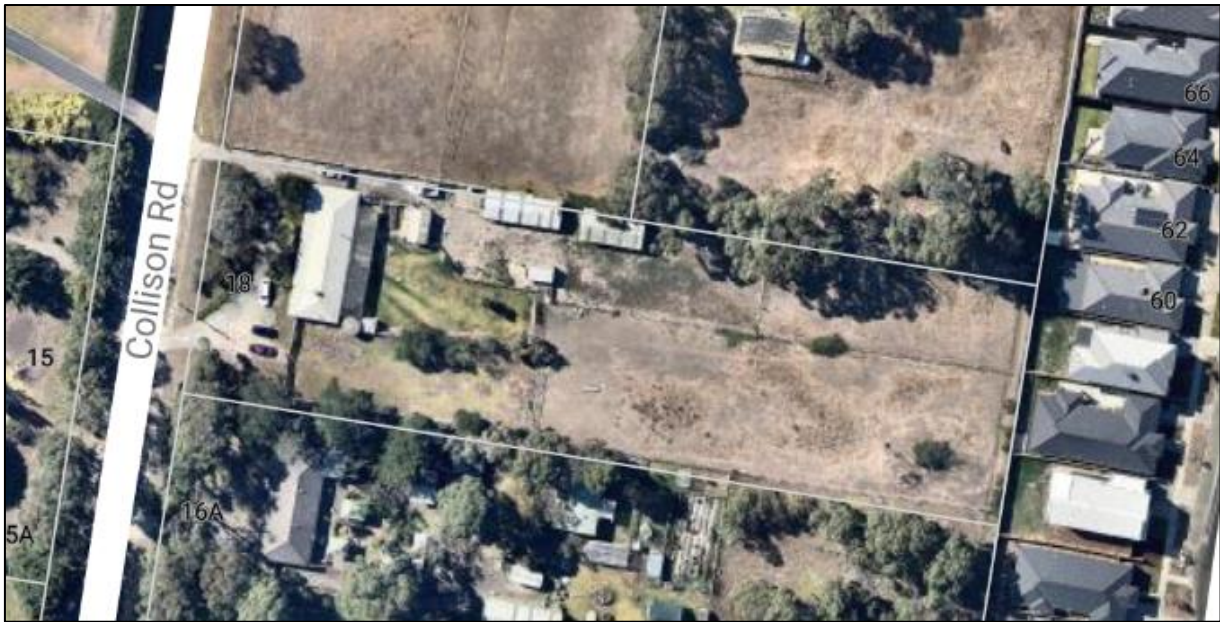
Site Description- No trees or other semi mature vegetation is growing in the rear yard. A couple of semi mature Eucalypts were observed growing within the front setback but none are remnant or mature in age. The understory is exotic.	
Species observed on site	<i>Eucalyptus sp</i> (trees) and exotic understory.
Approx. age of larger trees on site	20 years
Approx. tree heights	10 metres
Significant trees	No
Any habitat hollows observed	No
Is further targeted assessment required on this site	No

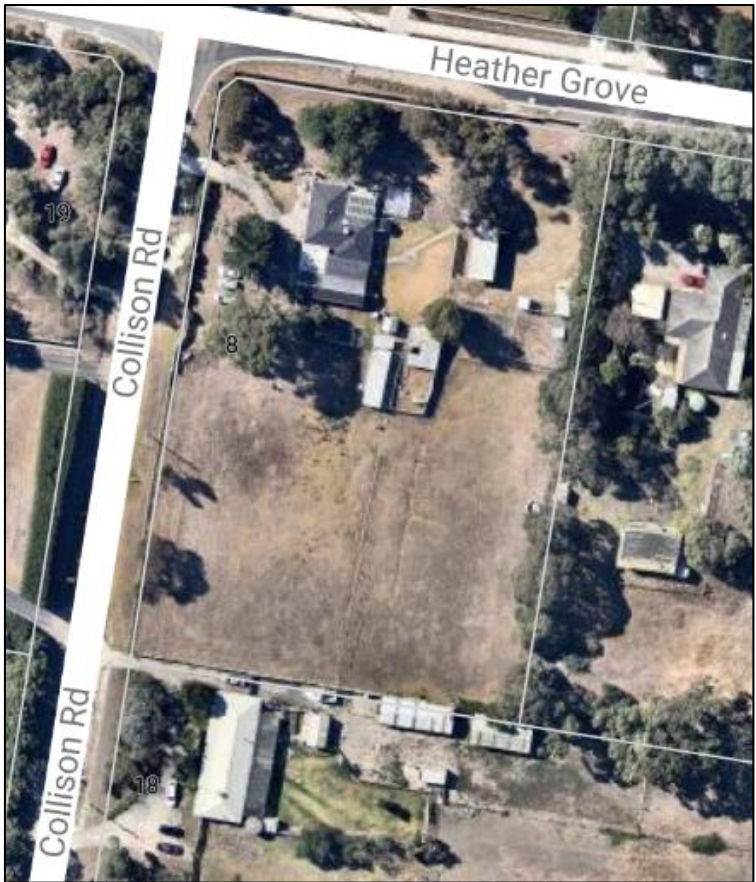
Site Description- All trees growing on the site have been assessed as planted. No trees on this site are considered high retention or require further assessment due their overall condition and species selection.	
Species observed on site	Native Eucalyptus sp
Approx. age of larger trees on site	30
Approx. tree heights	13
Significant trees	No
Any habitat hollows observed	No
Is further targeted assessment required on this site	No

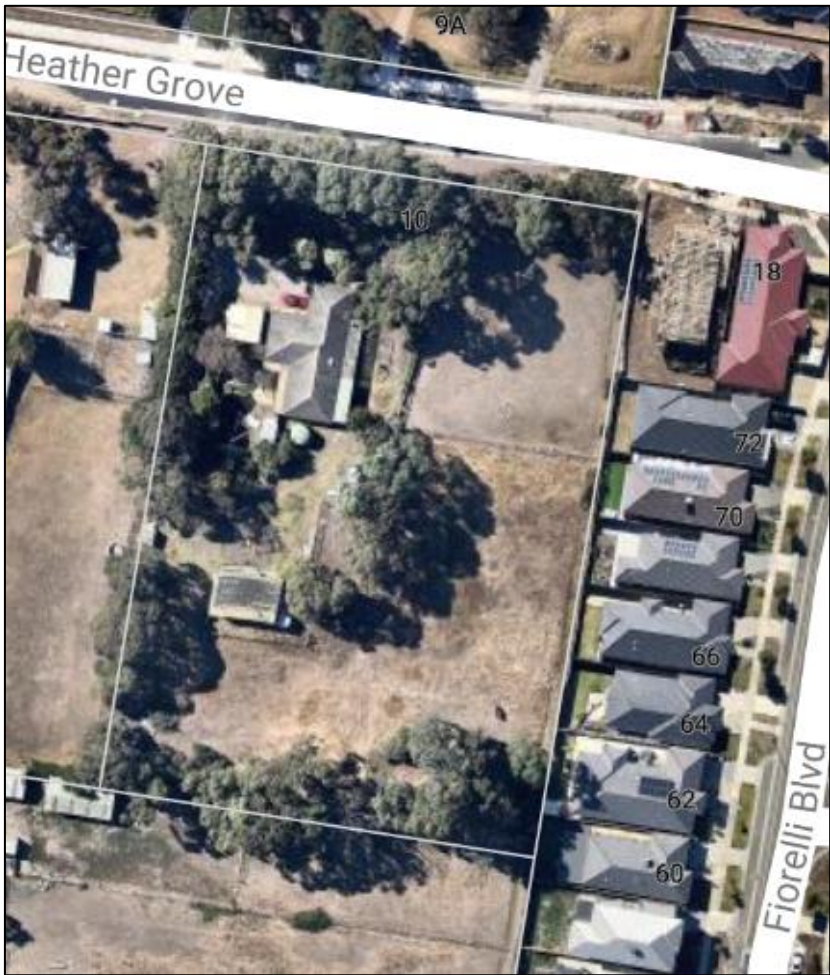
Site Description- This site is dominated by semi mature and mature Eucalyptus sp. The majority of the trees on this site look to be around 30- 40 years old although there are many trees growing in the rear yard that couldn't be accessed. A targeted assessment of trees on this site should be undertaken prior to making a final determination regarding tree removal. Image below shows native trees growing along the Heather Grove frontage.

Species observed on site	Eucalypt varieties
Approx. age of larger trees on site	30-40 years
Approx. tree heights	15 metres
Significant trees	No
Any habitat hollows observed	No
Is further targeted assessment required on this site	Yes- Targeted site visit

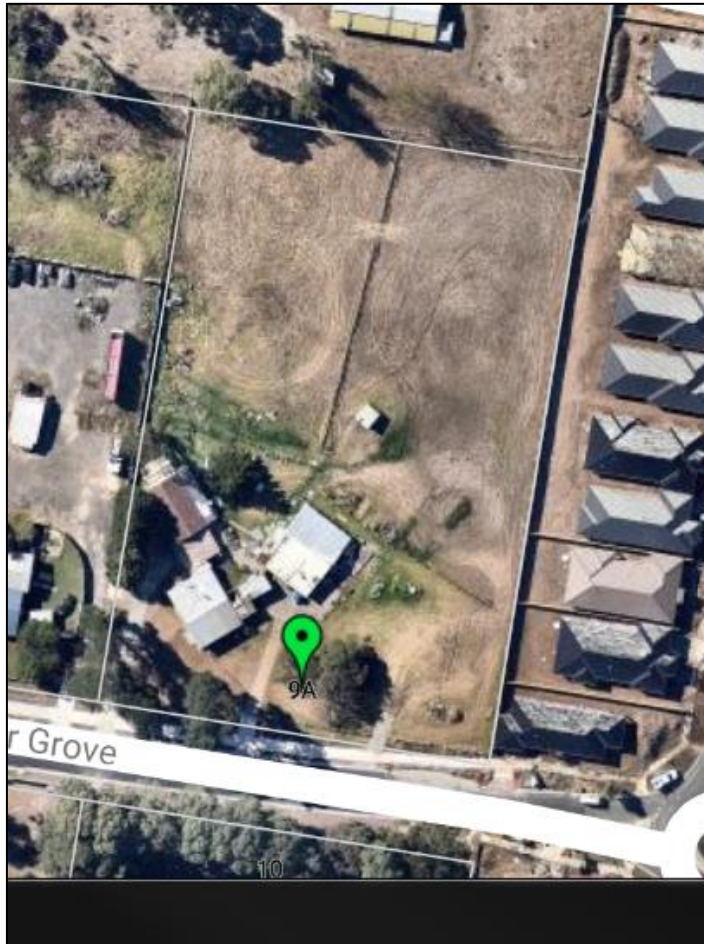
Site Description- No native vegetation was observed on site. The semi mature trees growing within the front setback are exotic Pine plantings. No further assessment is required.

Species observed on site	Exotic
Approx. age of larger trees on site	NA
Approx. tree heights	NA
Significant trees	NA
Any habitat hollows observed	NA
Is further targeted assessment required on this site	No

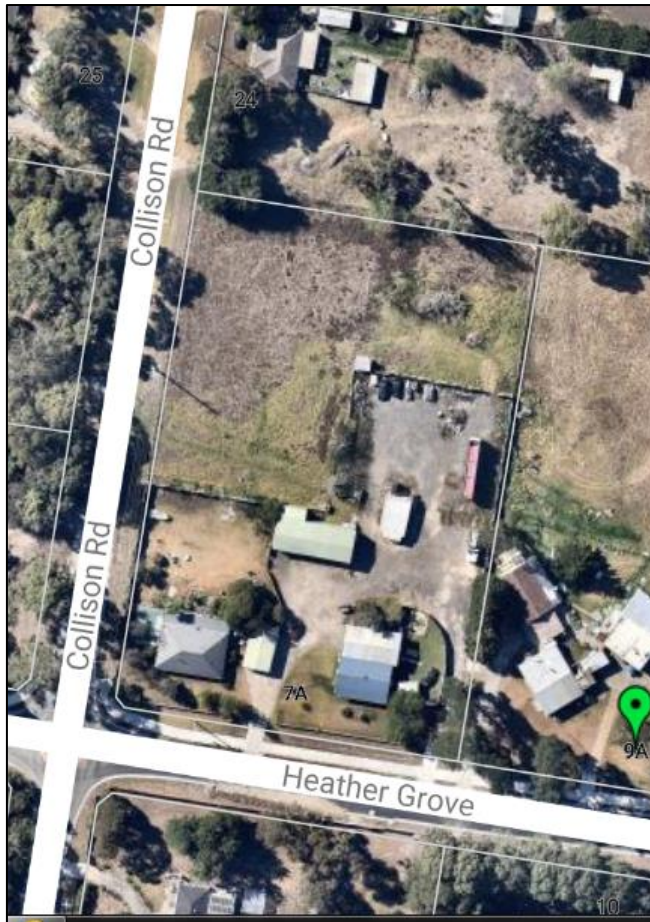
Site Description- No native vegetation over 15 years old was observed within 7A Heather Grove. All trees planting trees along boundaries are exotic and no further targeted assessment is required.

Species observed on site	Exotic
Approx. age of larger trees on site	NA
Approx. tree heights	NA
Significant trees	NA
Any habitat hollows observed	NA
Is further targeted assessment required on this site	No

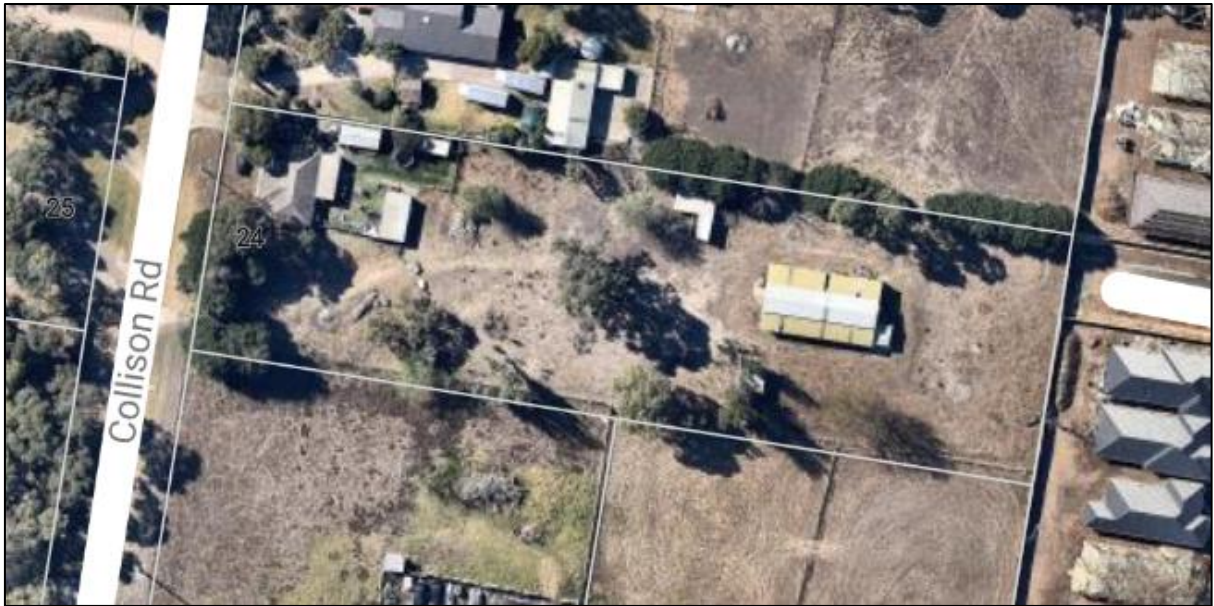
Site Description- Front setback of 24 Collison Road is dominated by exotic plantings. No remnant native vegetation was observed and no further targeted site assessments are required. The street tree growing within the road reserve is a topped *Eucalyptus sp* that is growing directly under HV wires and has poor structure.

Species observed on site	Native and exotic
Approx. age of larger trees on site	10-20 years old
Approx. tree heights	10 metres
Significant trees	No
Any habitat hollows observed	No
Is further targeted assessment required on this site	No

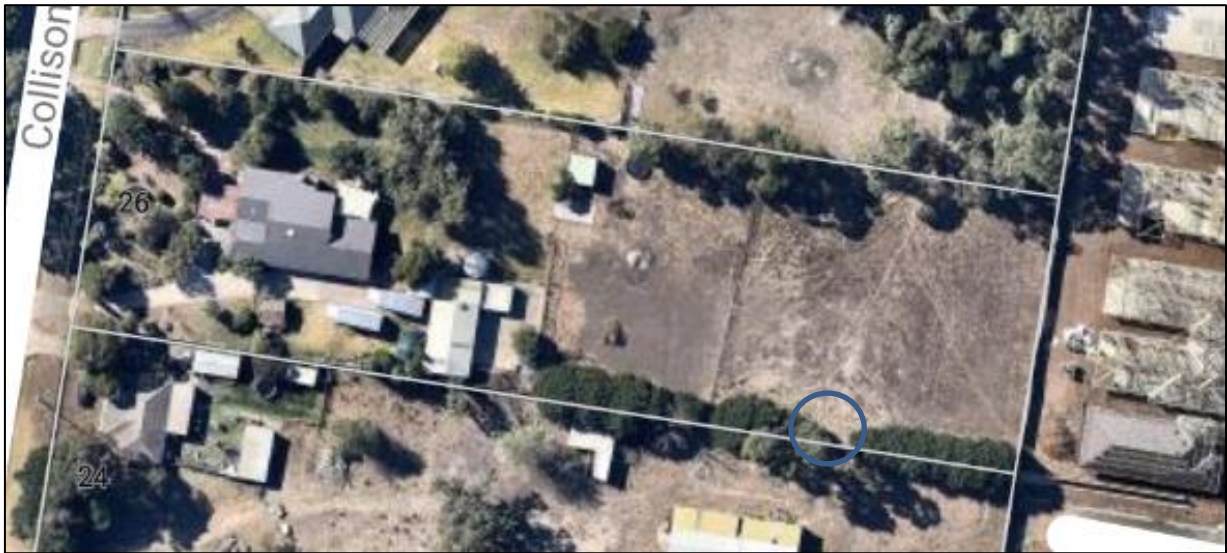
Site Description- Juvenile and young plantings dominate the front setback of the property. One large mature <i>Eucalyptus sp</i> is growing in the rear yard and requires a targeted assessment. The approximant location of this tree is highlighted in blue.	
Species observed on site	Native and Exotic
Approx. age of larger trees on site	30 -40 years
Approx. tree heights	15 plus
Significant trees	No
Any habitat hollows observed	No
Is further targeted assessment required on this site	Yes

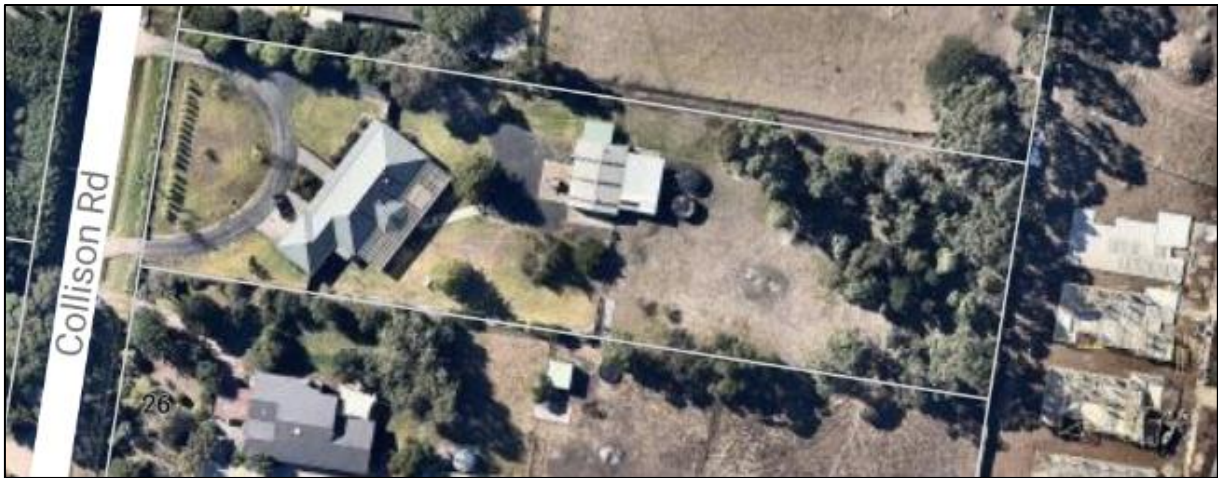
Site Description- Juvenile and young plantings are growing within the front setback of the property. Planted vegetation was also observed within the rear yard. No remnant vegetation was observed on site.	
Species observed on site	Native and exotic
Approx. age of larger trees on site	10-20 years
Approx. tree heights	NA
Significant trees	No
Any habitat hollows observed	No
Is further targeted assessment required on this site	No

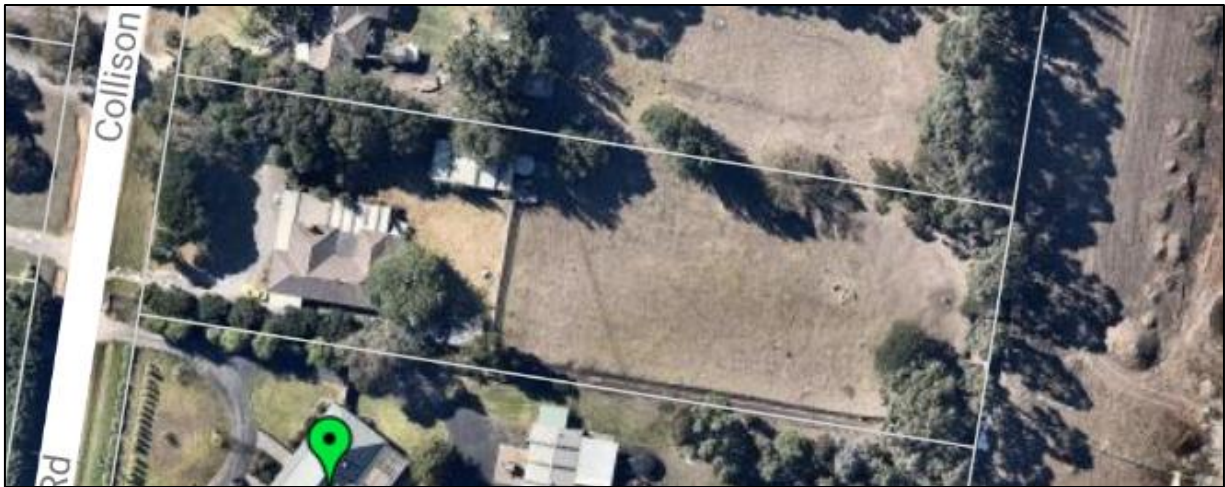
Site Description- Planted <i>Melaleuca armillaris</i> growing within the front setback. No mature or significant vegetation was observed in the rear yard of the property.	
Species observed on site	Native and exotic
Approx. age of larger trees on site	NA
Approx. tree heights	NA
Significant trees	No
Any habitat hollows observed	No
Is further targeted assessment required on this site	No

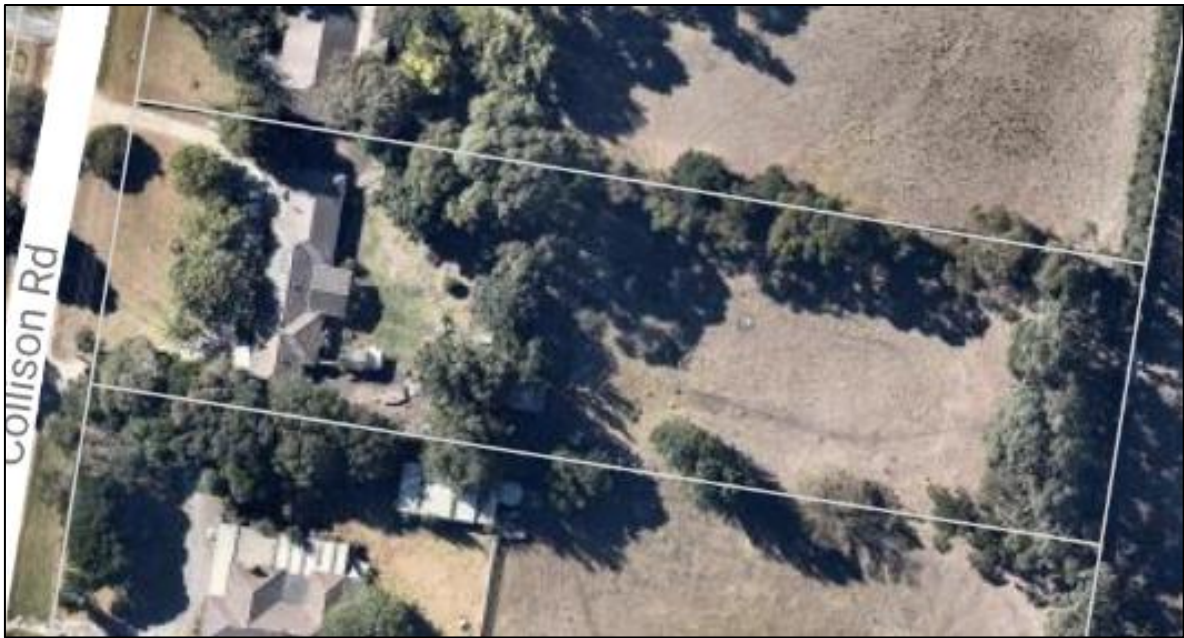
Site Description- Trees growing within the front setback are exotic Ash and Oak. The larger trees observed growing in the rear yard also exotic. No further targeted assessments are required for this site.	
Species observed on site	Exotic
Approx. age of larger trees on site	NA
Approx. tree heights	NA
Significant trees	No
Any habitat hollows observed	No
Is further targeted assessment required on this site	No

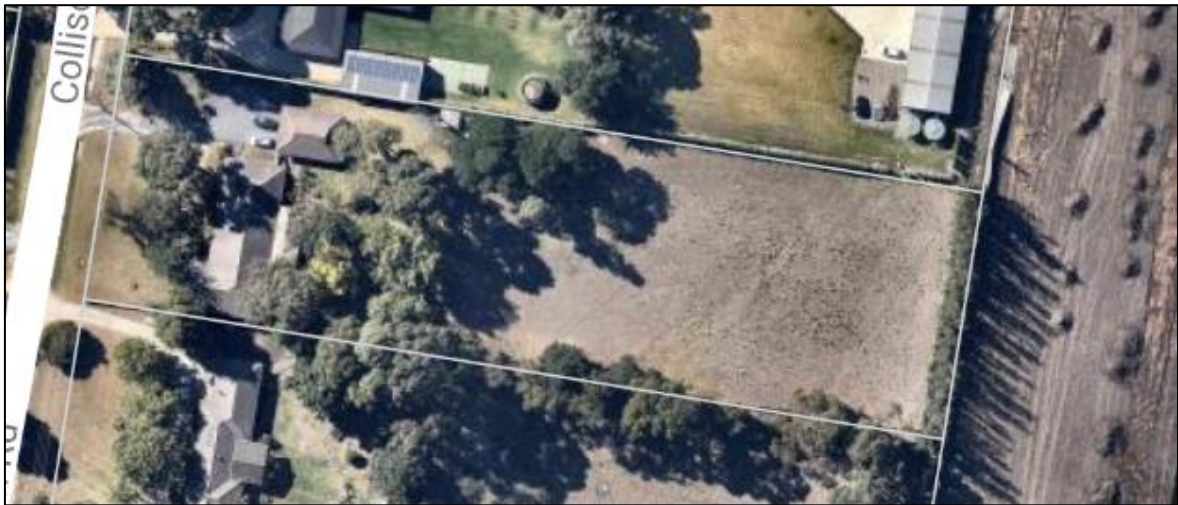
Site Description- Exotic and native trees were observed growing within the front setback of the property and within close proximity to the dwelling. All trees on site have been assessed as planted vegetation not over 20 years old and no further site assessments are required.	
Species observed on site	Native and exotic
Approx. age of larger trees on site	<20 years
Approx. tree heights	NA
Significant trees	No
Any habitat hollows observed	No
Is further targeted assessment required on this site	No

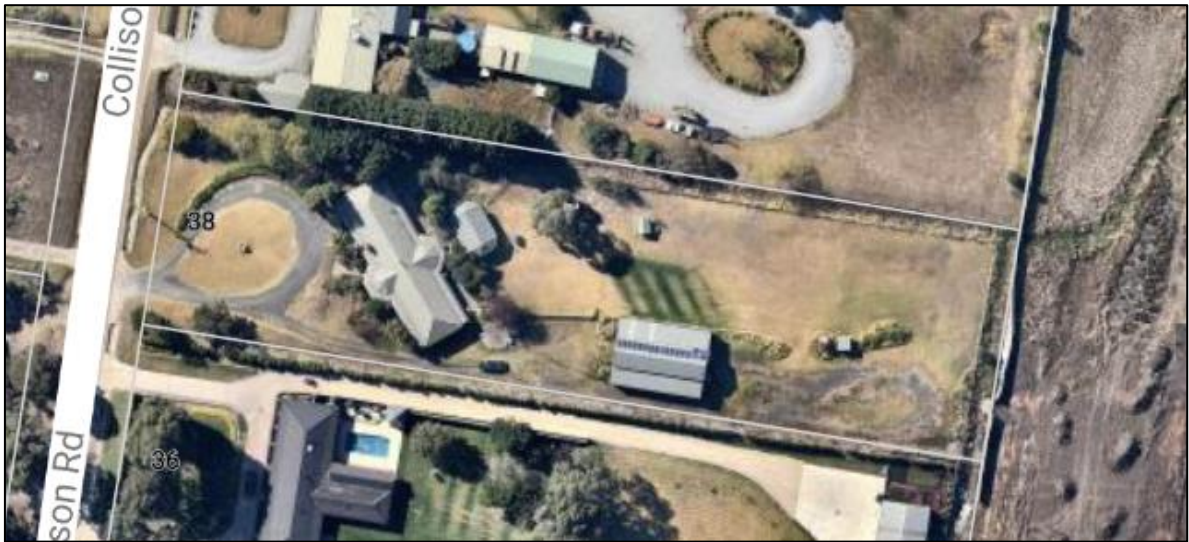
Site Description- Exotic Cypress trees are growing along the northern boundary. No native vegetation over 10 years old was observed on site.	
Species observed on site	Native and exotic
Approx. age of larger trees on site	10 years
Approx. tree heights	NA
Significant trees	No
Any habitat hollows observed	No
Is further targeted assessment required on this site	No

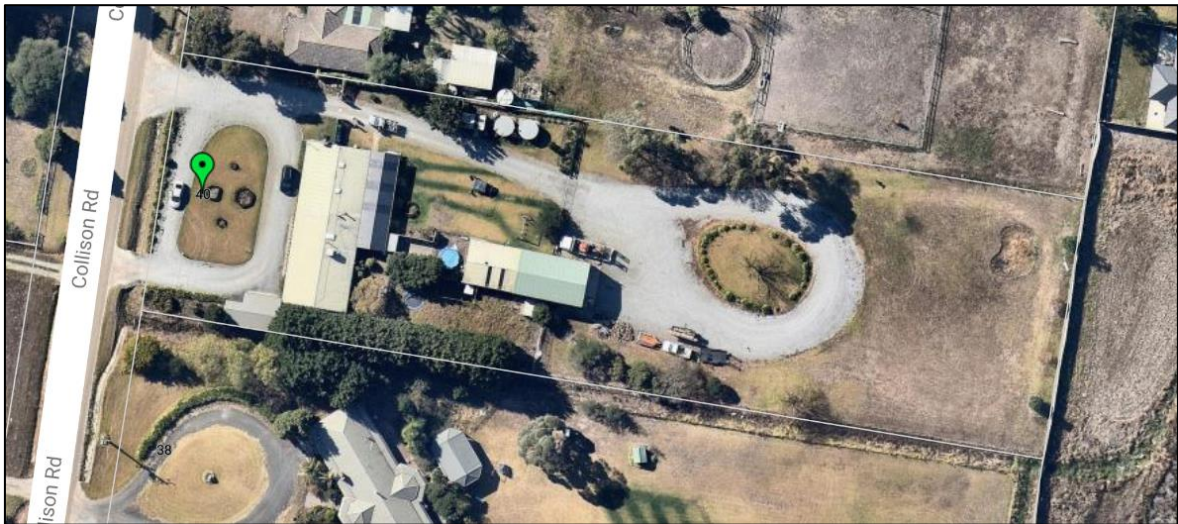
Site Description- No semi mature vegetation observed on site except for the exotic Cypress trees growing along the southern boundary. No remnant vegetation.	
Species observed on site	Exotic
Approx. age of larger trees on site	NA
Approx. tree heights	NA
Significant trees	No
Any habitat hollows observed	No
Is further targeted assessment required on this site	No

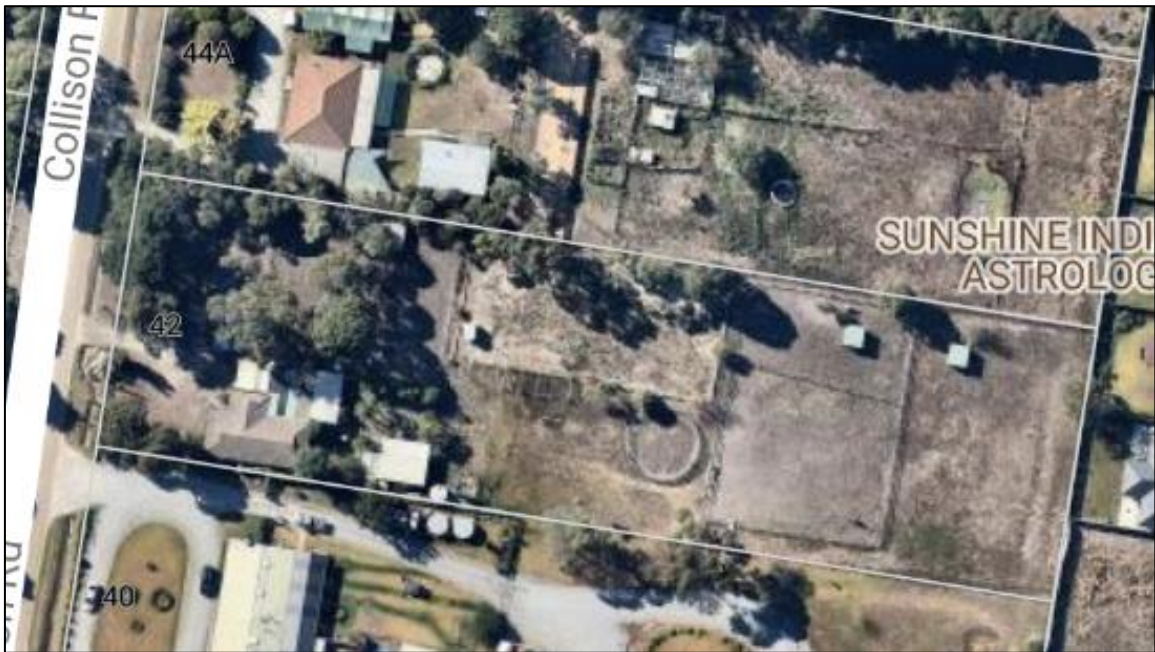
Site Description- The site is made up of a mix of native of exotic planting with the majority found within the front setback. No trees were assessed over 20 years old and no further targeted assessments are required.

Species observed on site	Native and exotic
Approx. age of larger trees on site	20 years
Approx. tree heights	10 metres
Significant trees	No
Any habitat hollows observed	No
Is further targeted assessment required on this site	No

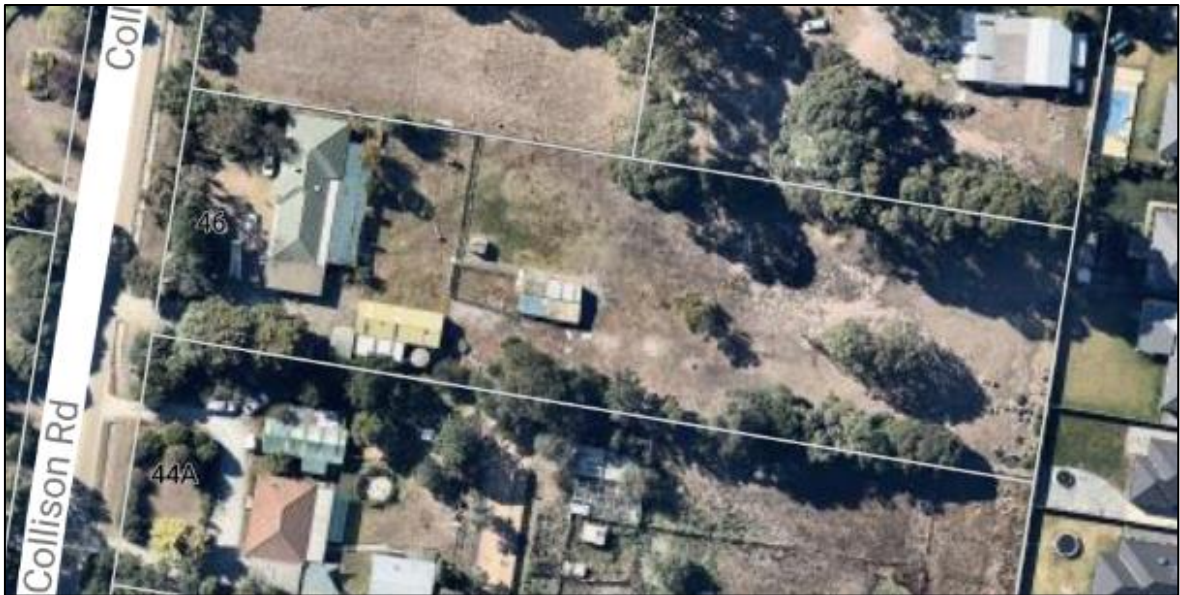
Site Description- The tree located within the front setback are planted specimens. There is also four street trees growing on the nature strip that have been planted. The trees have been topped to provide clearance from overhead HV wires. No remnant or mature trees observed.	
Species observed on site	Native and exotic
Approx. age of larger trees on site	NA
Approx. tree heights	NA
Significant trees	No
Any habitat hollows observed	No
Is further targeted assessment required on this site	No

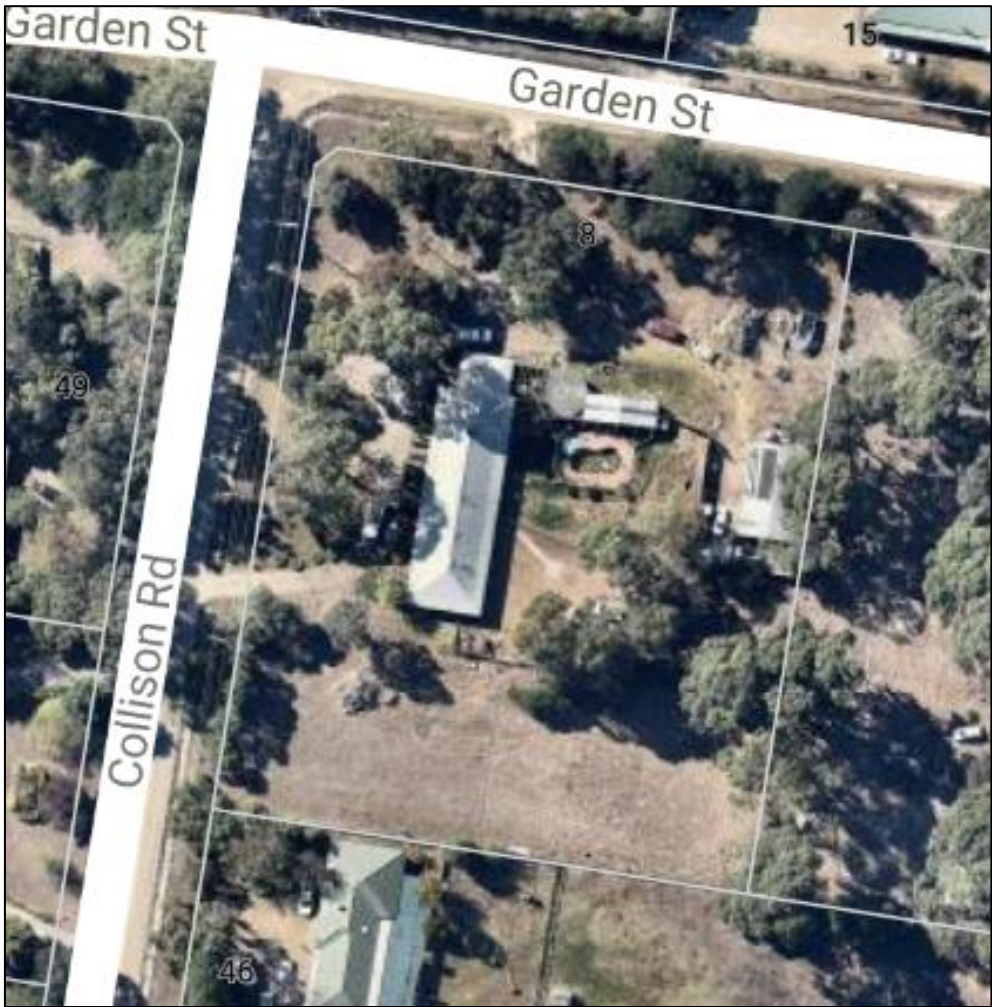
Site Description- Many planted Eucalypt trees are growing within close proximity to the existing dwelling. The majority are semi mature and no remnant trees were observed on site. The street trees growing adjacent to Garden Street are also planted and are a mix of exotic and natives.	
Species observed on site	Native and exotic
Approx. age of larger trees on site	20-30 years
Approx. tree heights	13 metres
Significant trees	No
Any habitat hollows observed	No
Is further targeted assessment required on this site	No

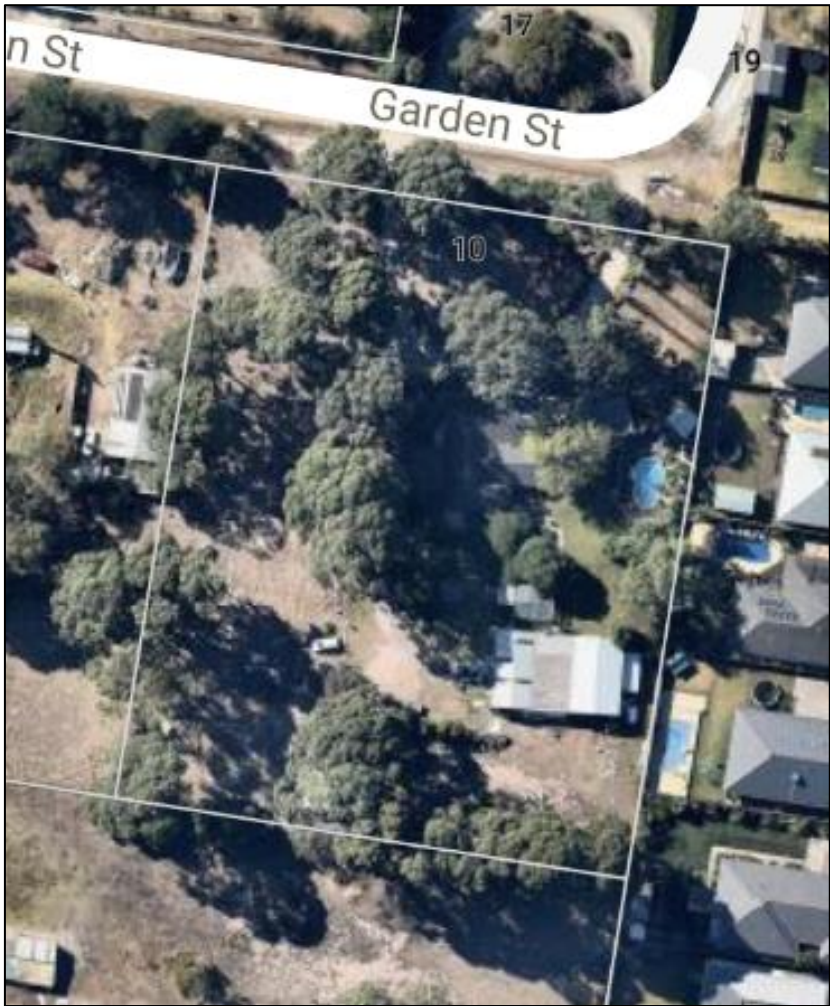
Site Description- This site is heavily vegetation with a number of mature native specimens observed throughout the site, both within the front setback and rear yard. Further targeted assessment is required to identify mature trees that might be worth including into any subdivision proposal.	
Species observed on site	Native
Approx. age of larger trees on site	30 years plus
Approx. tree heights	15 metres plus
Significant trees	No
Any habitat hollows observed	Unsure
Is further targeted assessment required on this site	Yes

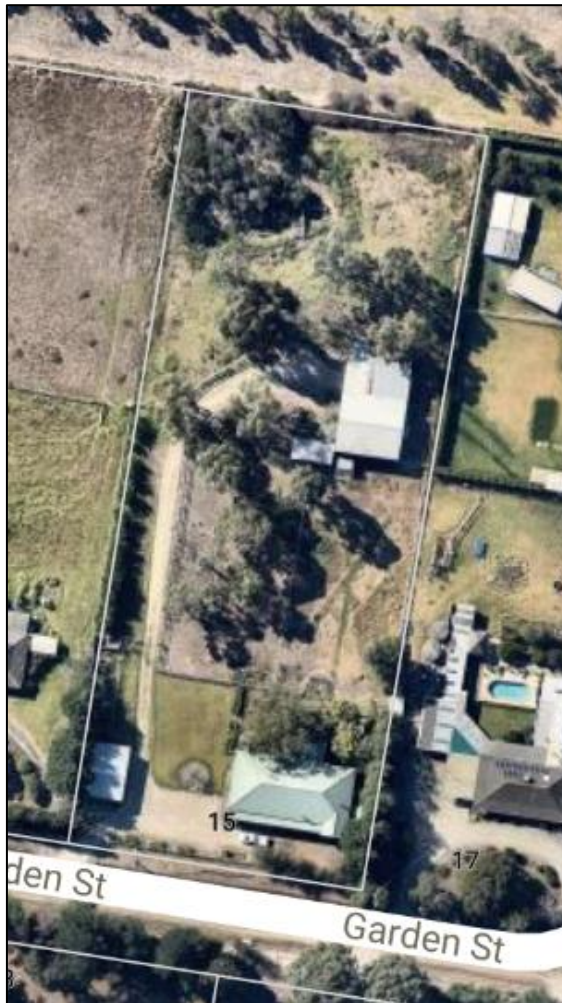
Site Description- This site has been planted out with native and exotic plantings. No trees on site are over 20 years old and no remnant or mature trees were observed.

Species observed on site	Native and exotic
Approx. age of larger trees on site	10-20 years
Approx. tree heights	5-10 metres
Significant trees	No
Any habitat hollows observed	No
Is further targeted assessment required on this site	No

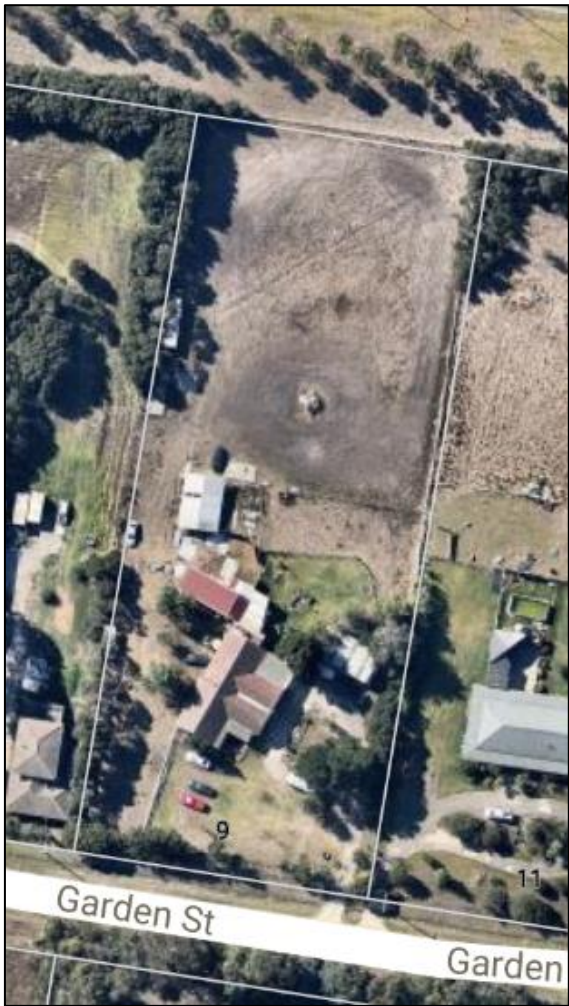
Site Description- No vegetation was observed growing in the rear yard. All vegetation growing within the front setback is young/semi mature in age.	
Species observed on site	Native and exotic
Approx. age of larger trees on site	10- 20 years
Approx. tree heights	10 metres
Significant trees	No
Any habitat hollows observed	No
Is further targeted assessment required on this site	No
