SUSTAINABLE TREE MANAGEMENT

PRELIMINARY TREE ASSESSMENT

Site Address:
Collison Estate, Cranbourne East

Prepared June 2018
Updated 17 May 2019

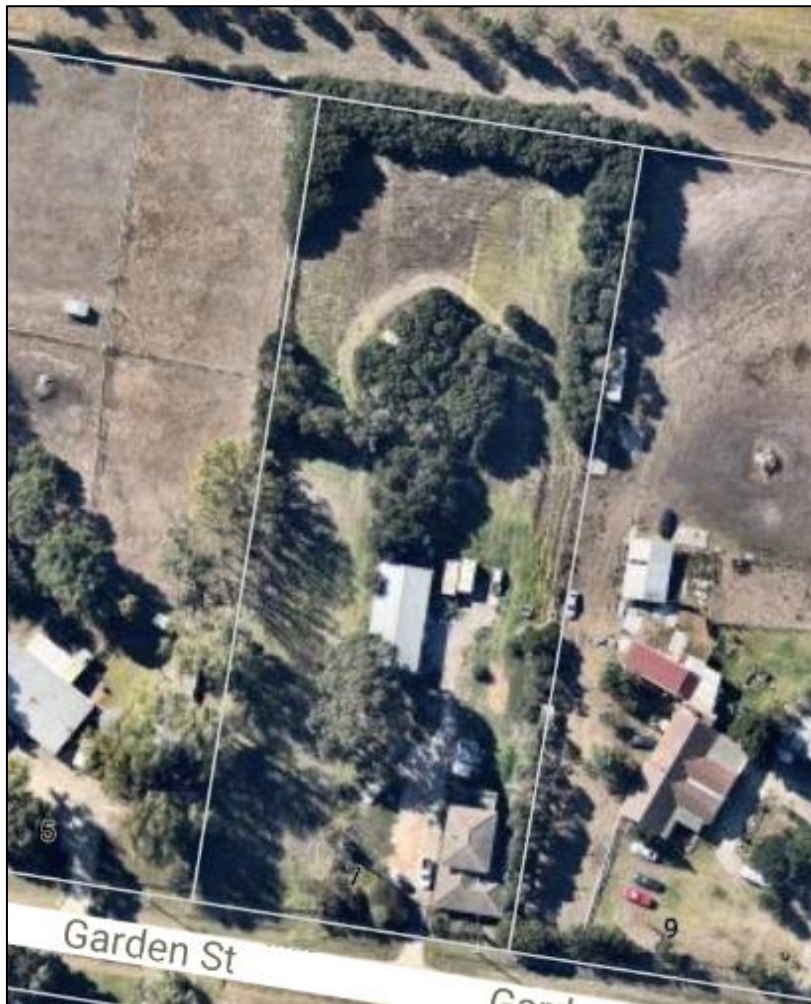
Site Description- All vegetation on site looks like it has been planted for screening and wind breaks. Semi mature natives were observed within the front setback. No remnant vegetation was observed.

Species observed on site	Native
Approx. age of larger trees on site	10-20 years
Approx. tree heights	10-15 metres
Significant trees	No
Any habitat hollows observed	No
Is further targeted assessment required on this site	No

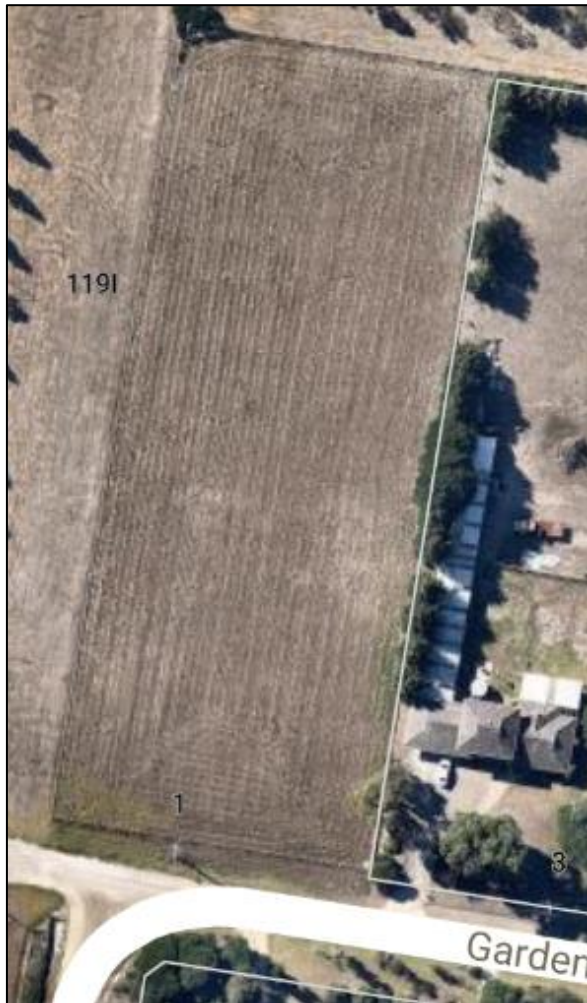
Site Description- No vegetation is growing on this site.

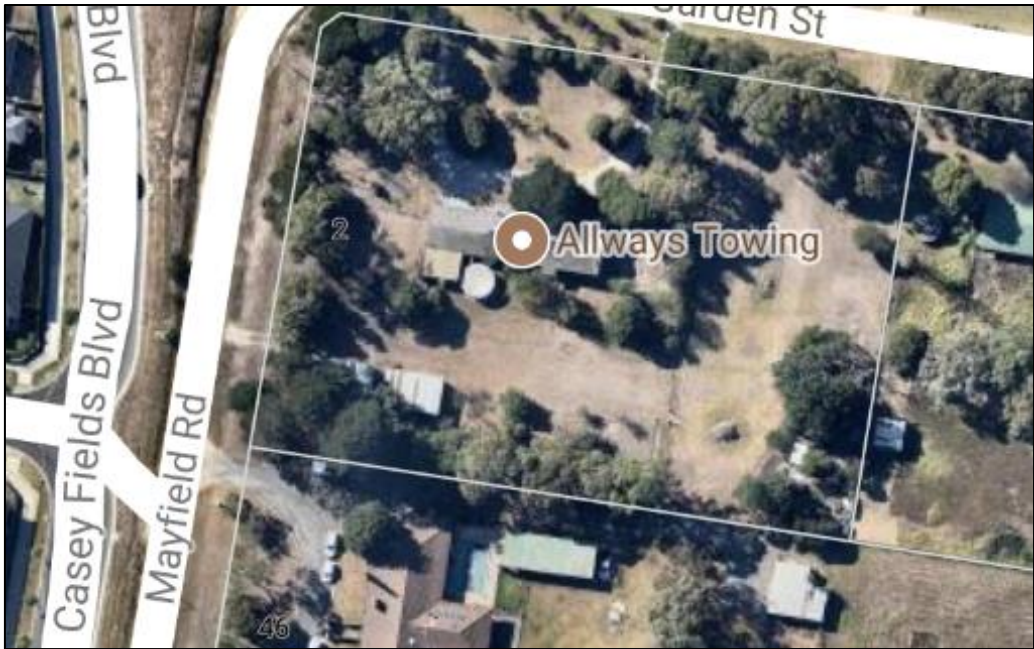
Site Description- The larger semi mature trees growing on this site face Mayfield Road. Smaller insignificant native plantings are found throughout the site. Street tree plantings are located adjacent Garden Street. These trees are semi mature in age. No remnant vegetation was observed on site.	
Species observed on site	Native
Approx. age of larger trees on site	Semi mature
Approx. tree heights	13 metres
Significant trees	No
Any habitat hollows observed	No
Is further targeted assessment required on this site	No

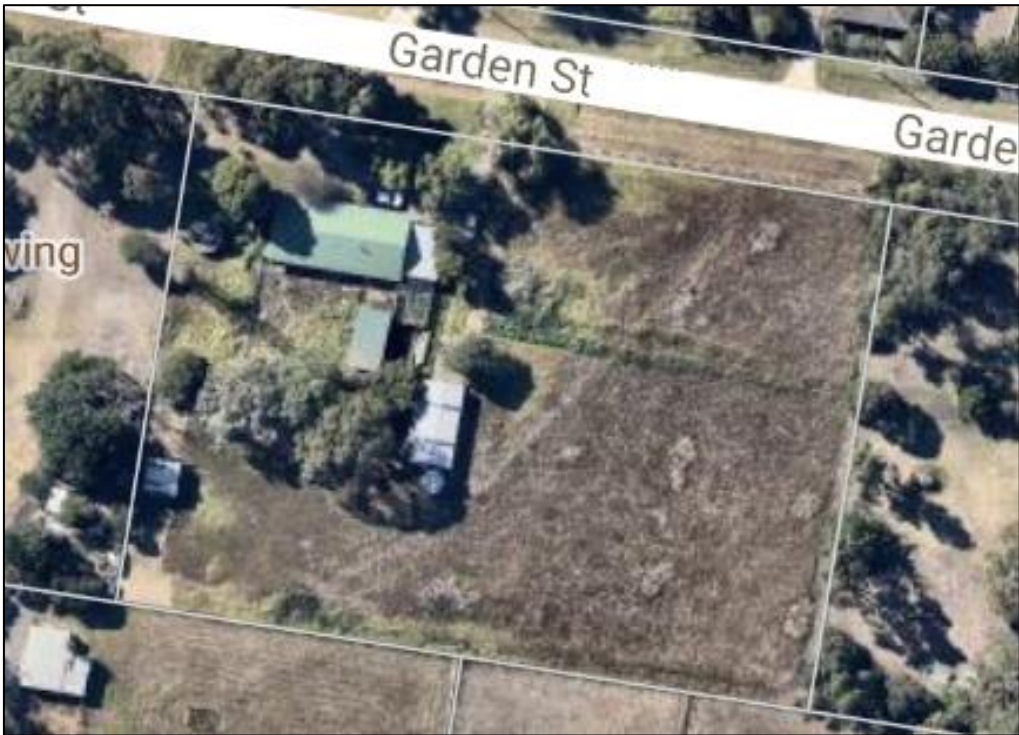
Site Description- Semi mature planted Eucalypts were observed on site. No trees over 25 years were assessed. Trees growing within the road reserve are planted Eucalypts. No further targeted assessments are required.

Species observed on site	Native
Approx. age of larger trees on site	Semi mature
Approx. tree heights	15 metres
Significant trees	No
Any habitat hollows observed	No
Is further targeted assessment required on this site	No

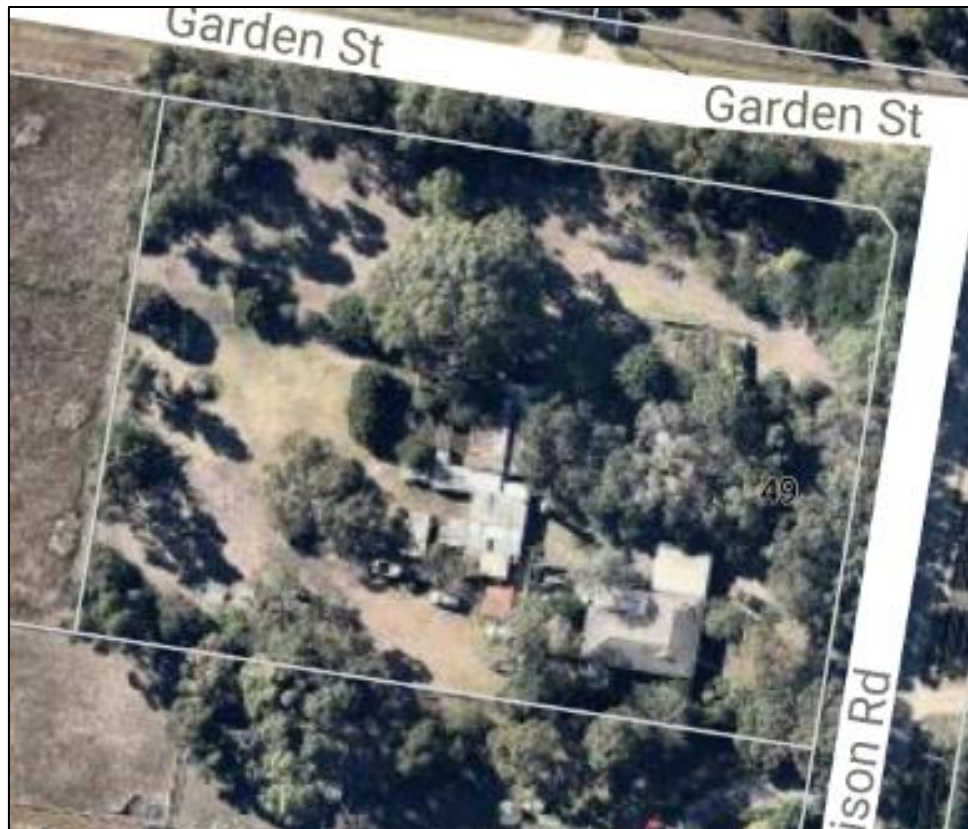
Site Description- Dense population of planted native vegetation growing around boundaries. Mature Eucalypt trees growing towards the middle to the site require further assessment. The Garden Street road reserve is also densely planted out with Blue Gums and understory that could be regrowth over 10 years old. A targeted assessment of this site and road reserve is required.

Species observed on site	Native
Approx. age of larger trees on site	Semi mature/mature
Approx. tree heights	15 metres
Significant trees	No
Any habitat hollows observed	NA
Is further targeted assessment required on this site	Yes

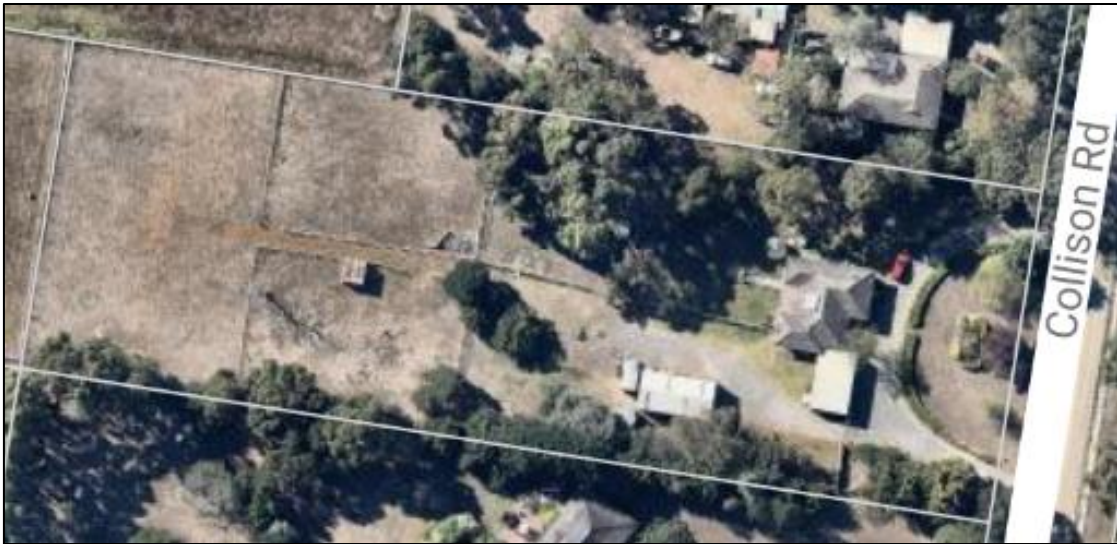
Site Description- Planted exotic Cypress trees are growing along the southern boundary. Semi mature to mature native tree are growing along the northern boundary. No remnant vegetation was viewed from the street.	
Species observed on site	Native and exotic
Approx. age of larger trees on site	Semi mature - mature
Approx. tree heights	10 metres
Significant trees	No
Any habitat hollows observed	No
Is further targeted assessment required on this site	No

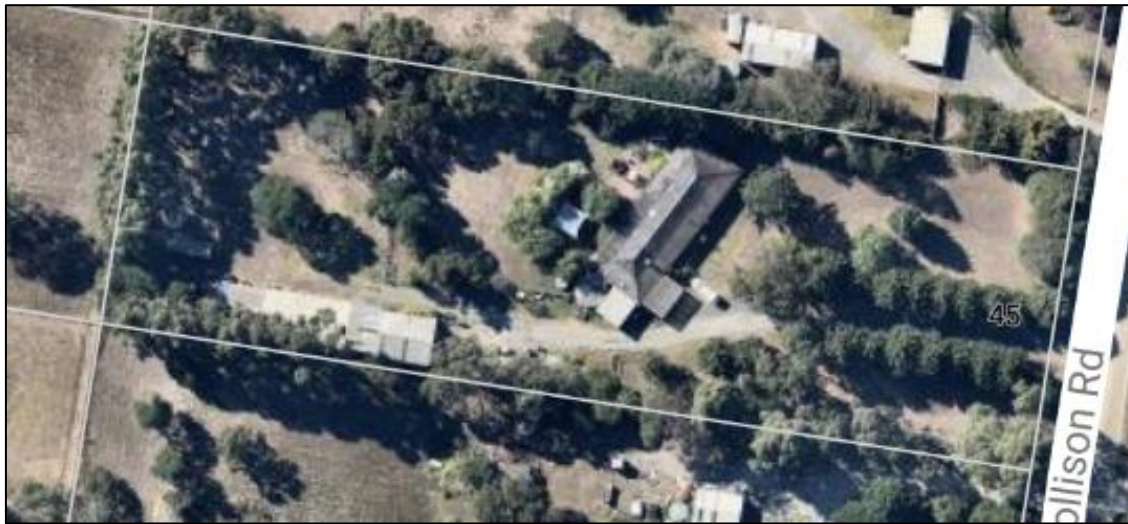
Site Description- Dense exotic screen plantings growing within the front setback. Native trees growing in the rear yard require a targeted assessment. Site access is required.

Species observed on site	Native and exotic
Approx. age of larger trees on site	NA
Approx. tree heights	NA
Significant trees	No
Any habitat hollows observed	NA
Is further targeted assessment required on this site	Yes

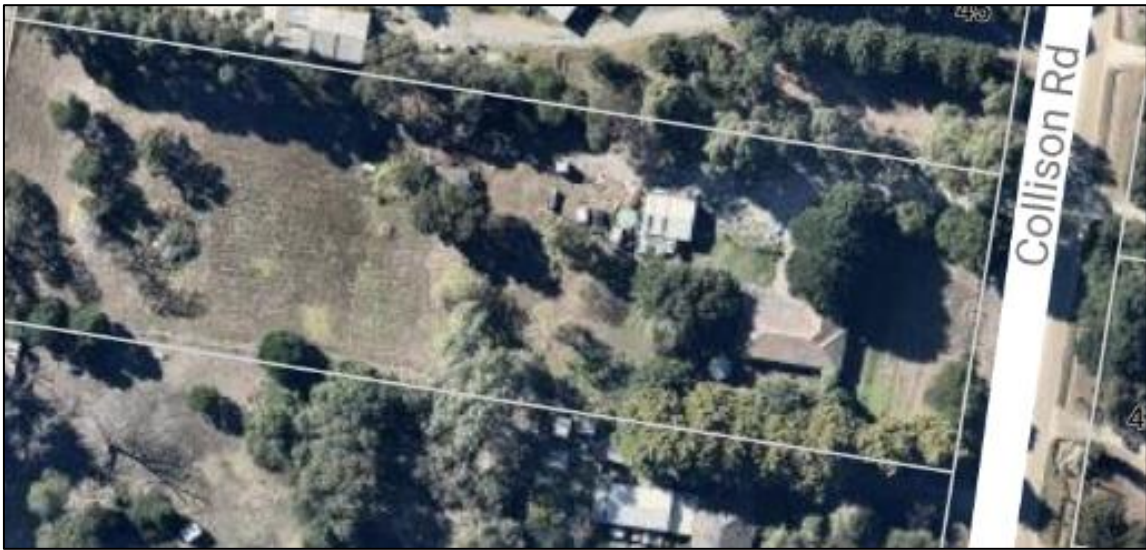
Site Description- The majority of vegetation growing on this site is exotic plantings with smaller planted Eucalypt trees also viewed. No mature or remnant vegetation was observed on site.

Species observed on site	Native and exotic
Approx. age of larger trees on site	10 years
Approx. tree heights	NA
Significant trees	No
Any habitat hollows observed	No
Is further targeted assessment required on this site	No

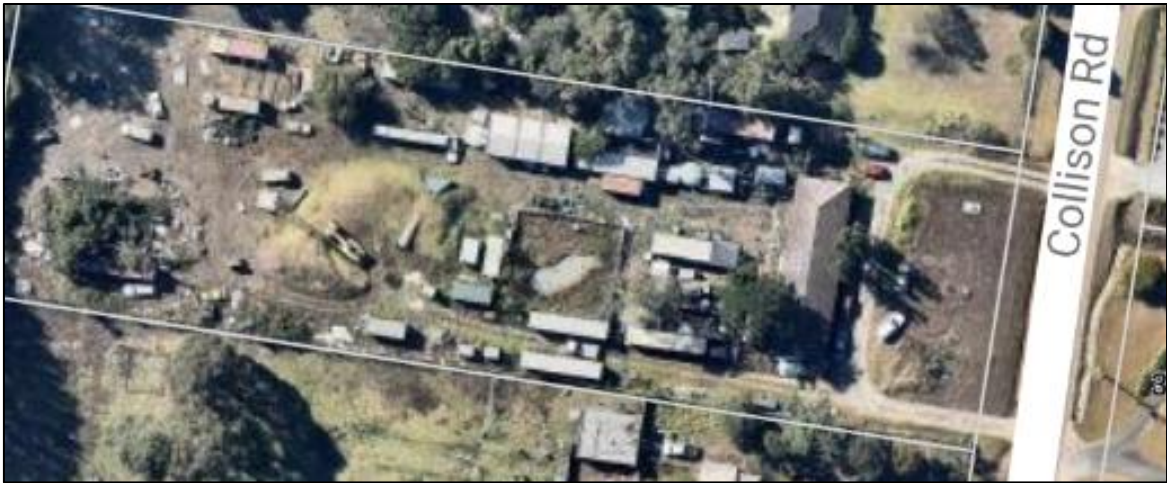
Site Description- Very little native vegetation observed on site. Majority of vegetation is exotic plantings.	
Species observed on site	Native and exotic
Approx. age of larger trees on site	NA
Approx. tree heights	NA
Significant trees	No
Any habitat hollows observed	NA
Is further targeted assessment required on this site	No

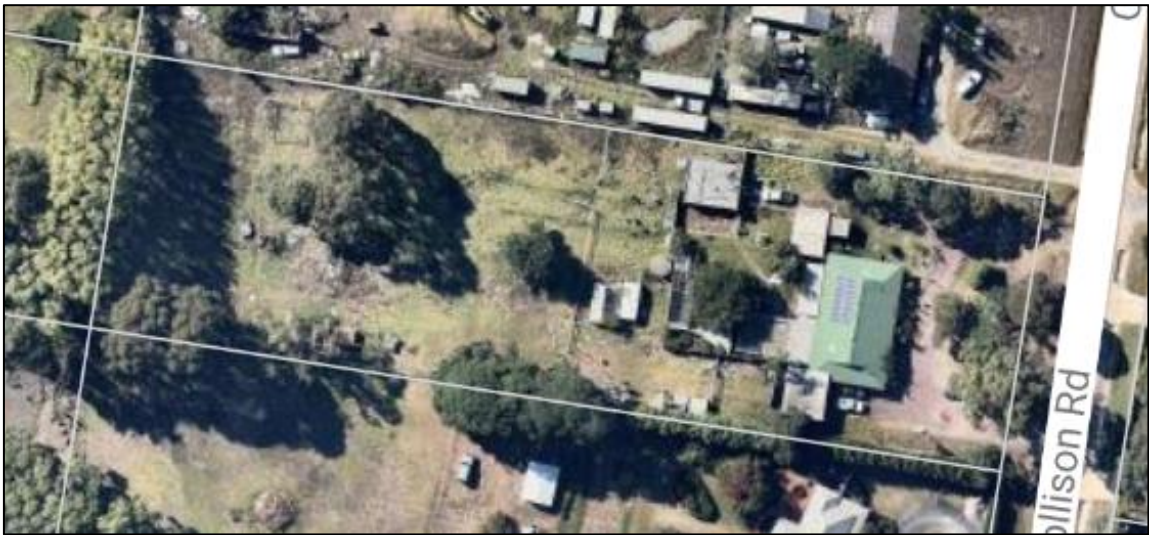
Site Description- Exotic plantings are growing along the rear boundary. All native vegetation growing on site is assessed as planted and no further targeted assessments are required. Two native planted street trees are growing within the road reserve.	
Species observed on site	Native and exotic
Approx. age of larger trees on site	Semi mature
Approx. tree heights	10 metres
Significant trees	No
Any habitat hollows observed	No
Is further targeted assessment required on this site	No

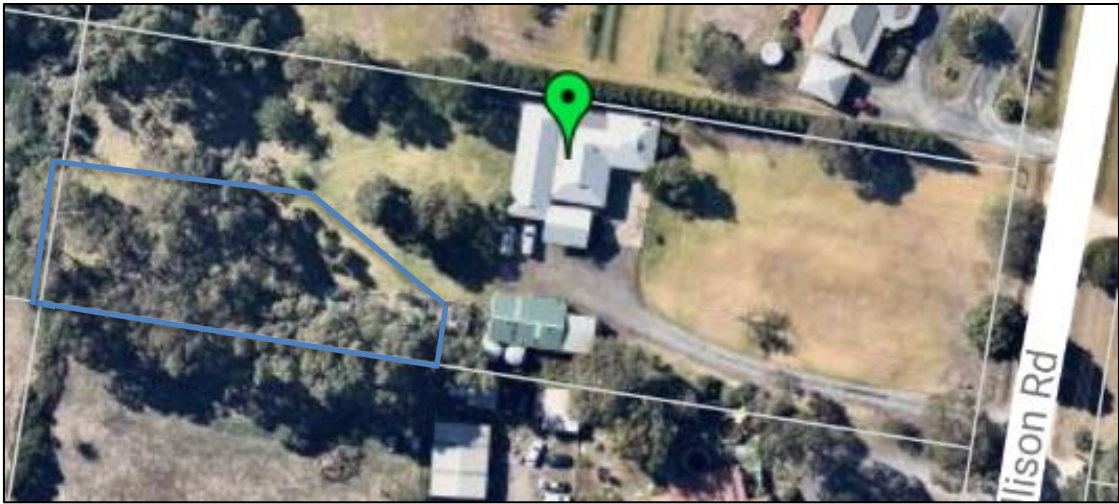
Site Description- No remnant trees observed within the front setback. Native trees growing within the rear yard look to be planted but I cannot confirm without a closer targeted inspection. The trees that require a further inspection have been highlighted in blue.	
Species observed on site	Native and exotic
Approx. age of larger trees on site	25 years plus
Approx. tree heights	15 metres
Significant trees	No
Any habitat hollows observed	NA
Is further targeted assessment required on this site	Yes

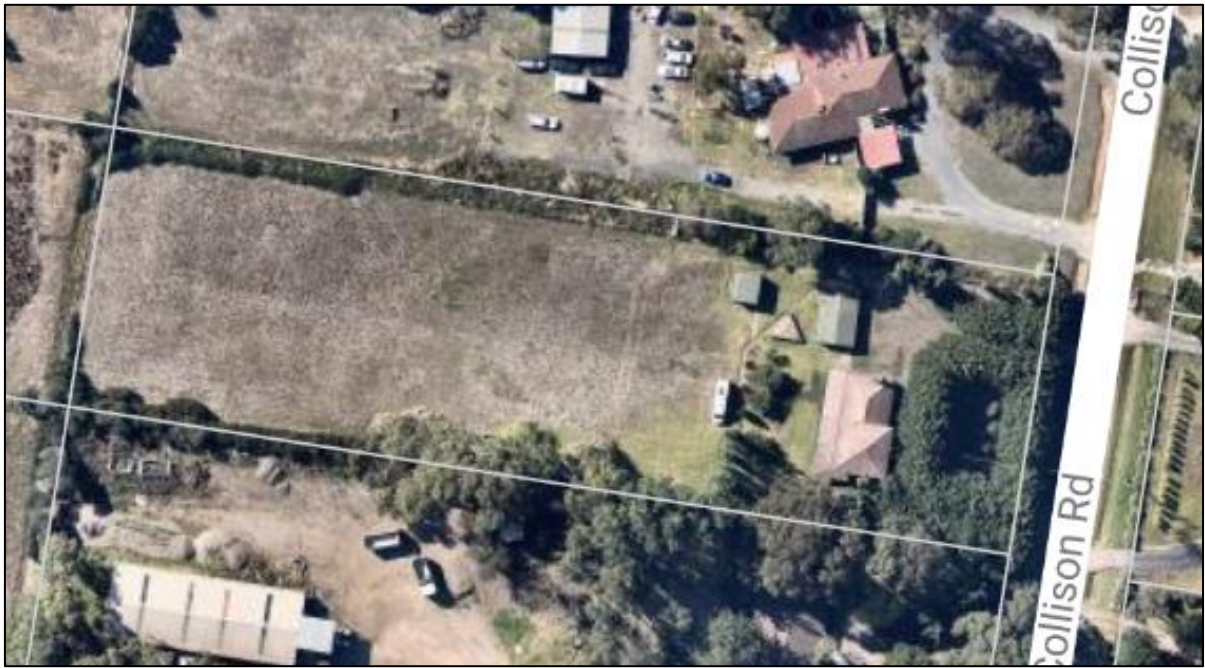
Site Description- The entire front setback is planted with exotic Cypress trees. One semi mature native Eucalypt was observed growing along the southern boundary. No native vegetation on site is considered remnant.	
Species observed on site	Native and exotic
Approx. age of larger trees on site	15 years plus
Approx. tree heights	10 metres
Significant trees	No
Any habitat hollows observed	No
Is further targeted assessment required on this site	No

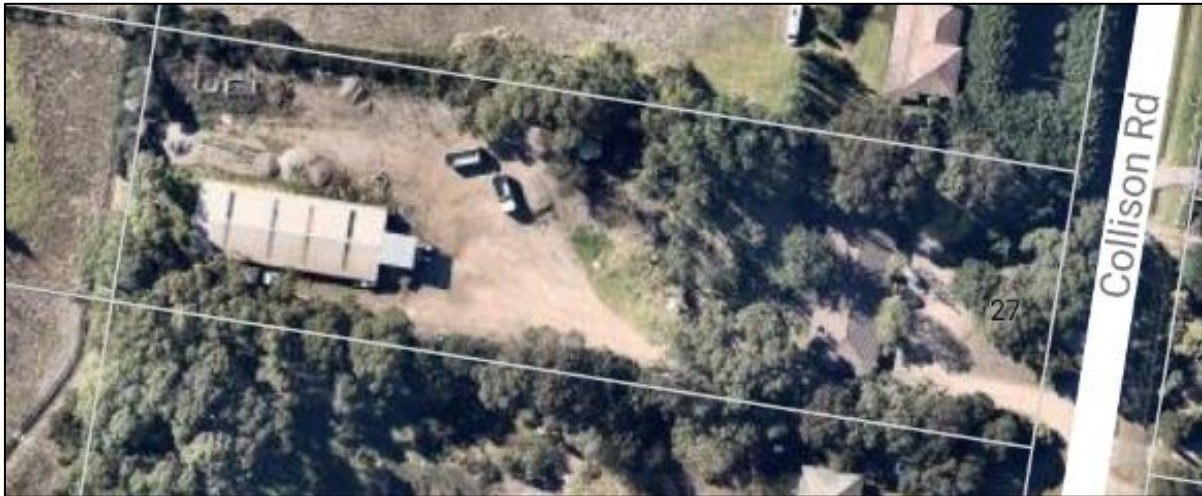
Site Description- Dense planting of semi mature native and exotic specimens. No mature or remnant vegetation was observed. Two planted semi mature Blue Gums are growing within the road reserve.	
Species observed on site	Native and exotic
Approx. age of larger trees on site	NA
Approx. tree heights	NA
Significant trees	No
Any habitat hollows observed	No
Is further targeted assessment required on this site	No

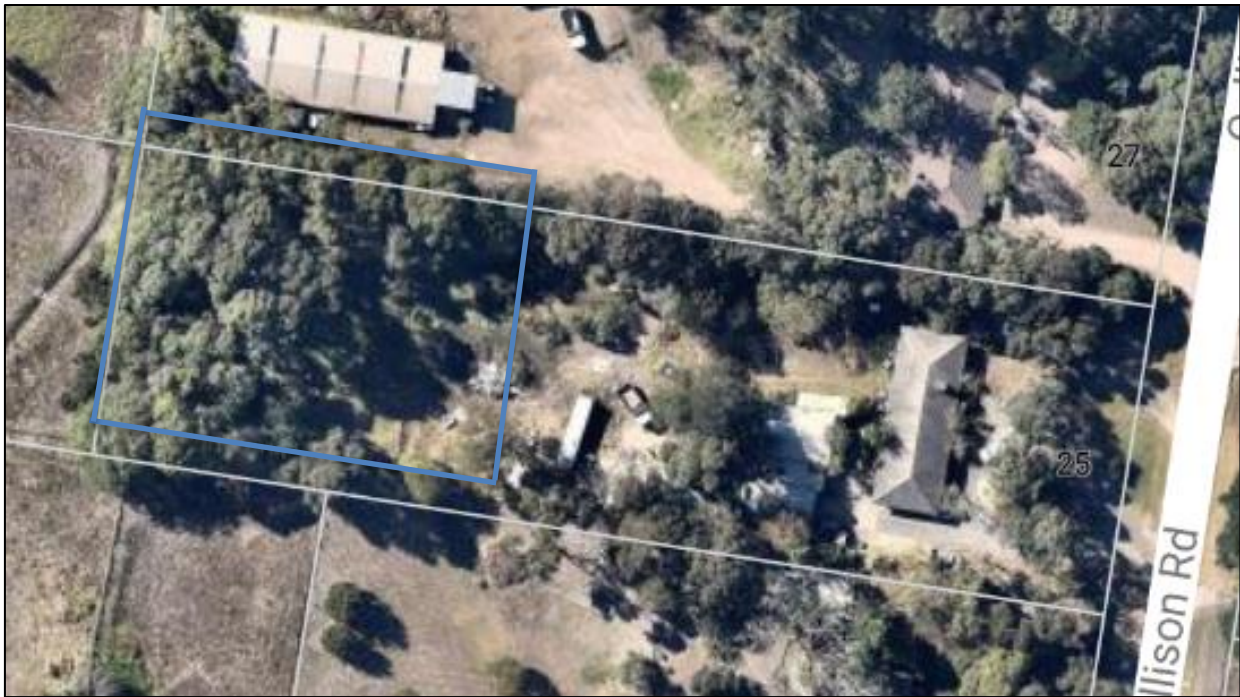
Site Description- Dense native vegetation on site. Unable to view trees growing in the rear yard from the road side. A targeted assessment of native vegetation growing within the rear yard is required. The area of targeted assessment is been highlighted in blue.	
Species observed on site	Native
Approx. age of larger trees on site	Semi mature - mature
Approx. tree heights	NA
Significant trees	No
Any habitat hollows observed	No
Is further targeted assessment required on this site	Yes

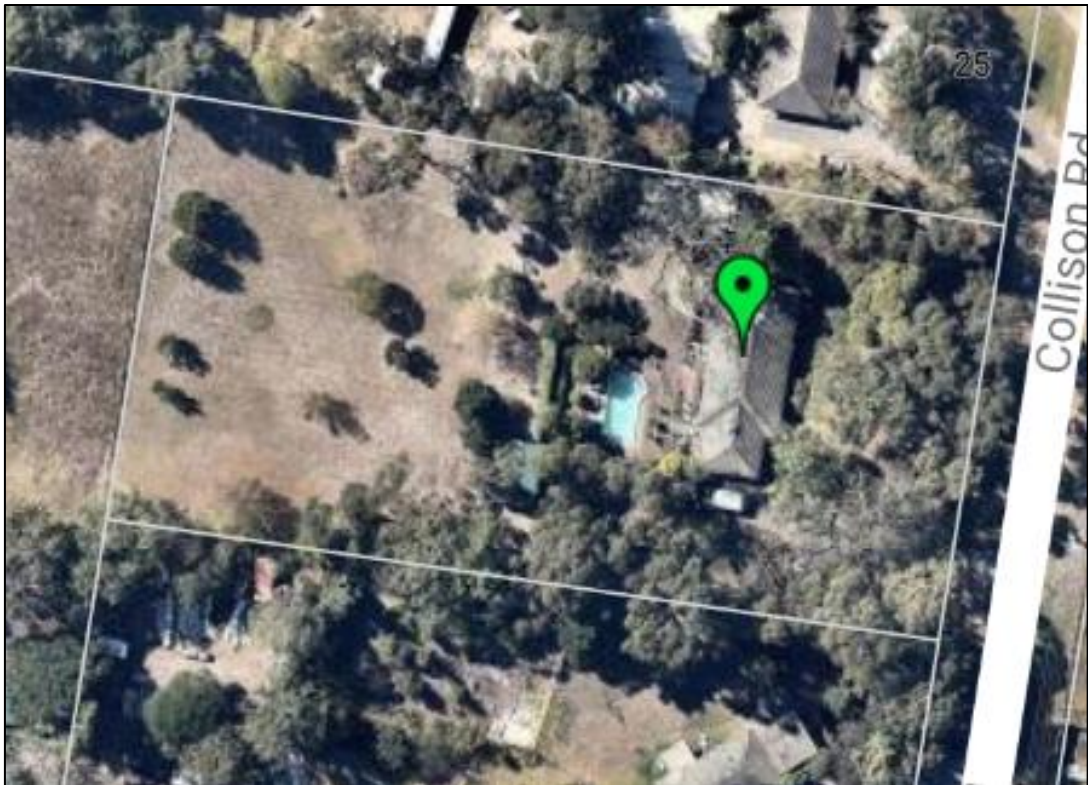
Site Description- Dense Eucalypt plantings within the front setback. No mature or remnant vegetation observed from roadside.	
Species observed on site	Native
Approx. age of larger trees on site	Semi mature
Approx. tree heights	10 metres
Significant trees	No
Any habitat hollows observed	No
Is further targeted assessment required on this site	No

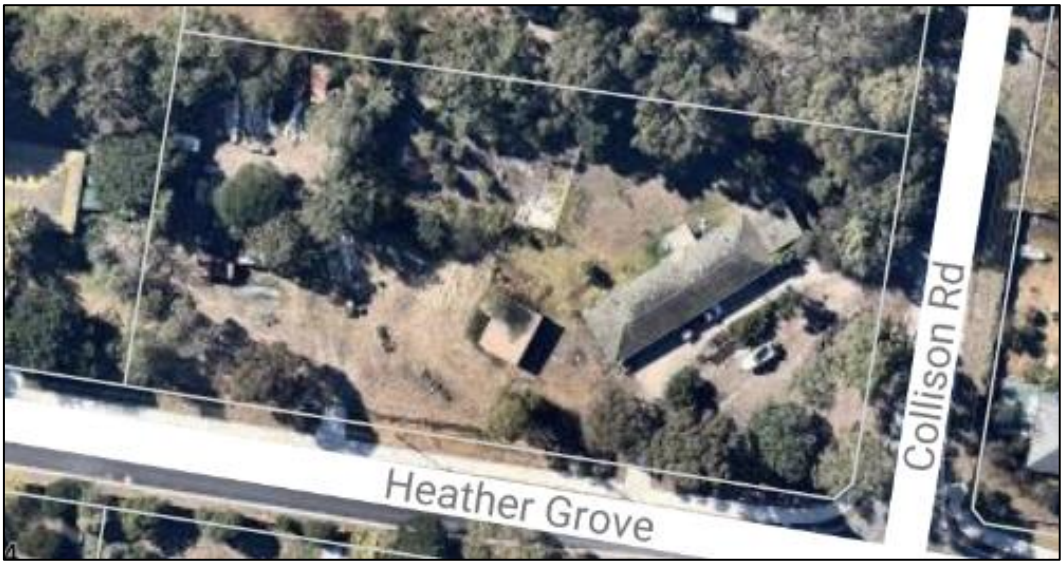
Site Description- Semi mature planted Eucalypt trees were observed within the front setback. No remnant vegetation noted.	
Species observed on site	Native
Approx. age of larger trees on site	Semi mature
Approx. tree heights	13 metres
Significant trees	No
Any habitat hollows observed	No
Is further targeted assessment required on this site	No

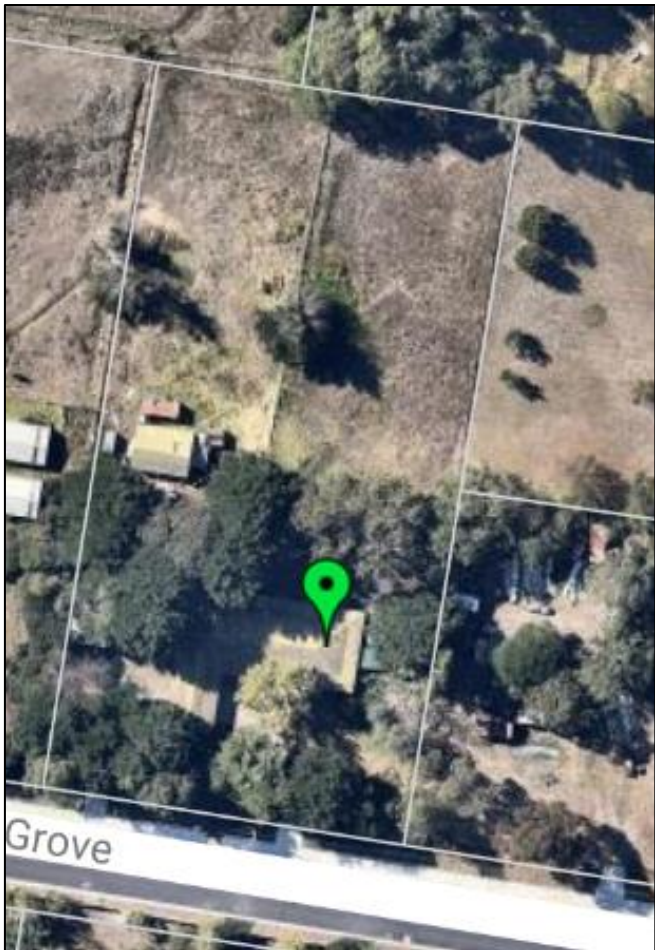
Site Description- Larger trees on site are planted Cypress. No semi mature native vegetation was observed.	
Species observed on site	Native and exotic
Approx. age of larger trees on site	NA
Approx. tree heights	NA
Significant trees	No
Any habitat hollows observed	No
Is further targeted assessment required on this site	NA

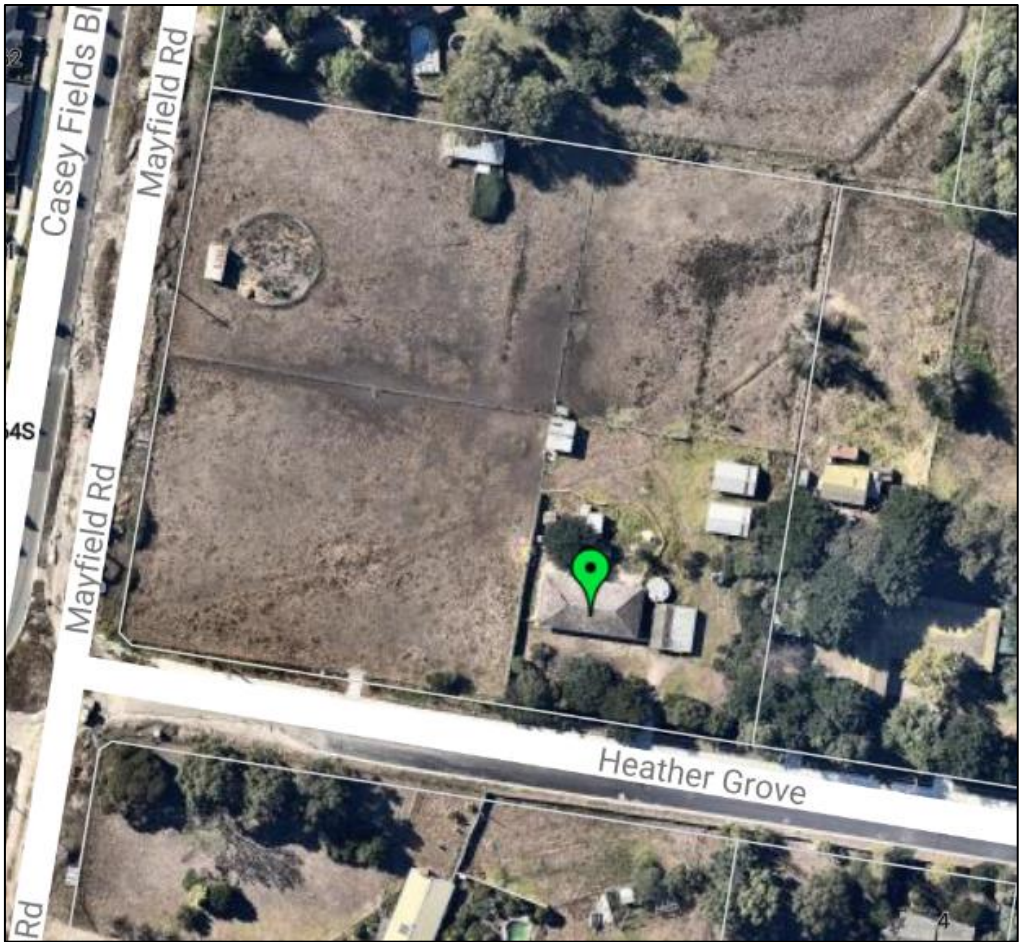
Site Description- Larger trees on site are planted Cypress. No semi mature native vegetation was observed.	
Species observed on site	Native and exotic
Approx. age of larger trees on site	NA
Approx. tree heights	NA
Significant trees	No
Any habitat hollows observed	No
Is further targeted assessment required on this site	NA

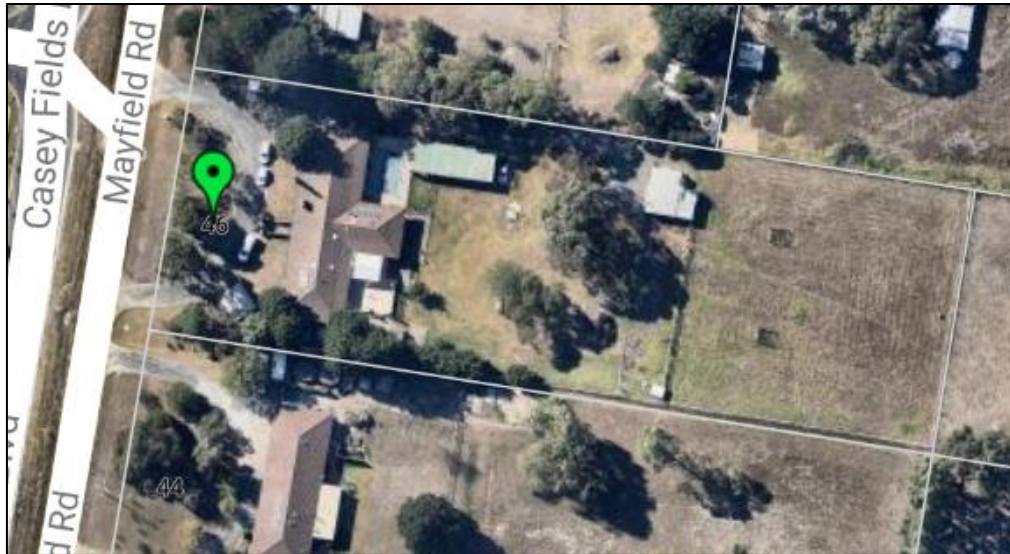
Site Description- Semi mature Eucalypt trees are growing within the front setback of the property. No mature vegetation was observed on the property.

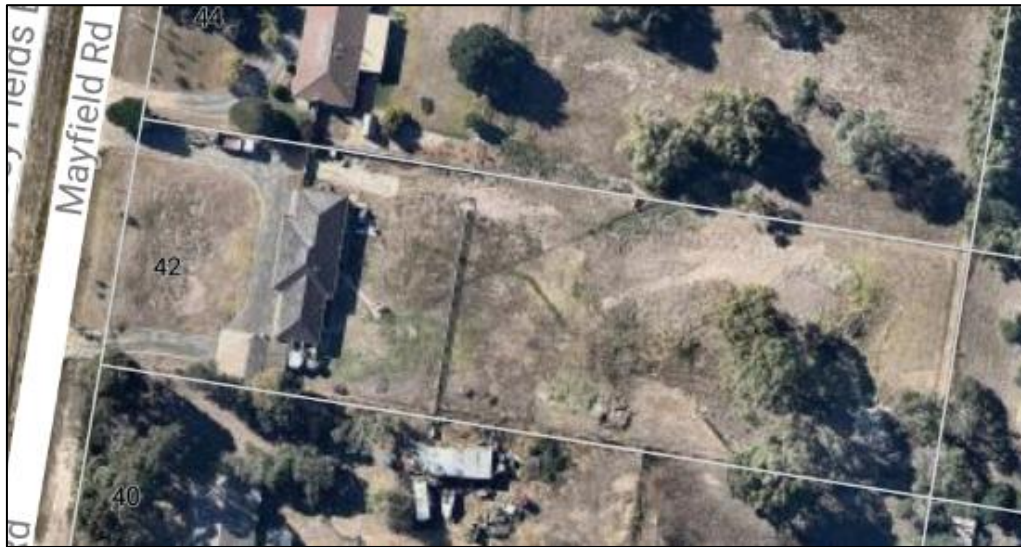
Site Description- The front setback is clear of vegetation. Three semi mature Eucalypts are growing in the rear yard. No trees on site are mature or remnant.

Species observed on site	Native
Approx. age of larger trees on site	15-20 years
Approx. tree heights	12 metres
Significant trees	No
Any habitat hollows observed	No
Is further targeted assessment required on this site	No

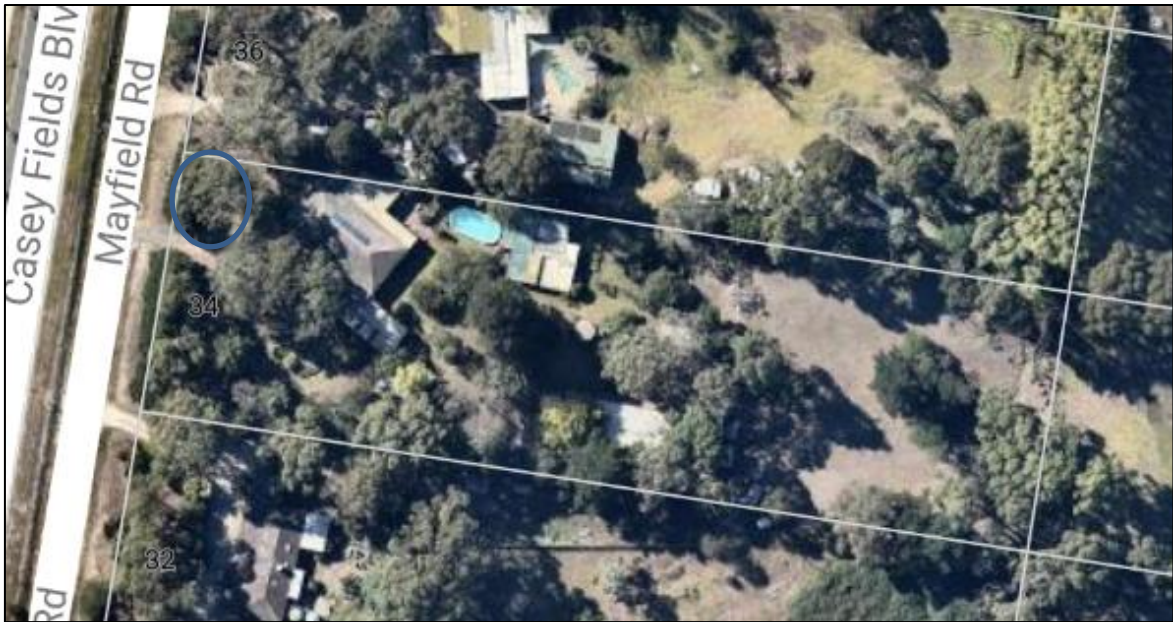
Site Description- Dense native plantings within the property boundaries. 40, 38, 36, 34 and 32 Mayfair Road have dense vegetation plantings and each site is side by side. One mature <i>Eucalyptus viminalis</i> growing in the front setback. This particular tree has been highlighted in blue and a photograph has also been provided. Further targeted tree assessments of these sites is recommended.	
Species observed on site	Native and indigenous
Approx. age of larger trees on site	Semi mature - mature
Approx. tree heights	10-15 metres
Significant trees	No
Any habitat hollows observed	No
Is further targeted assessment required on this site	No

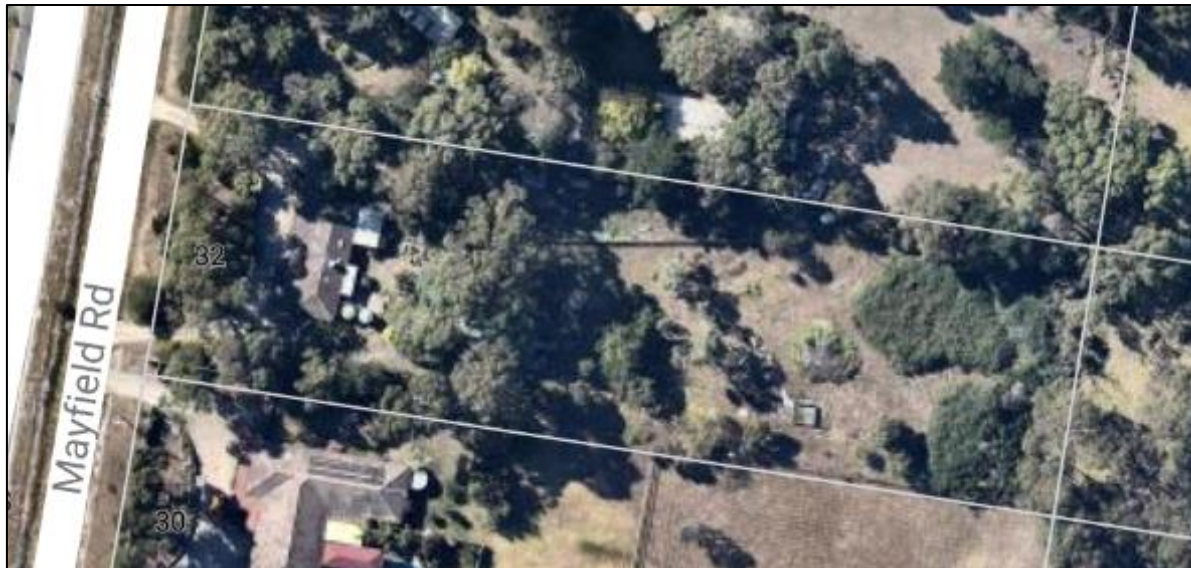
Site Description- Semi mature and mature native plantings were observed within the front setback of the property. No trees on site are assessed as remnant. Number 40, 38, 36, 34 and 32 Mayfair Road have dense vegetation plantings and each site is side by side. Further targeted tree assessments of these sites is recommended.

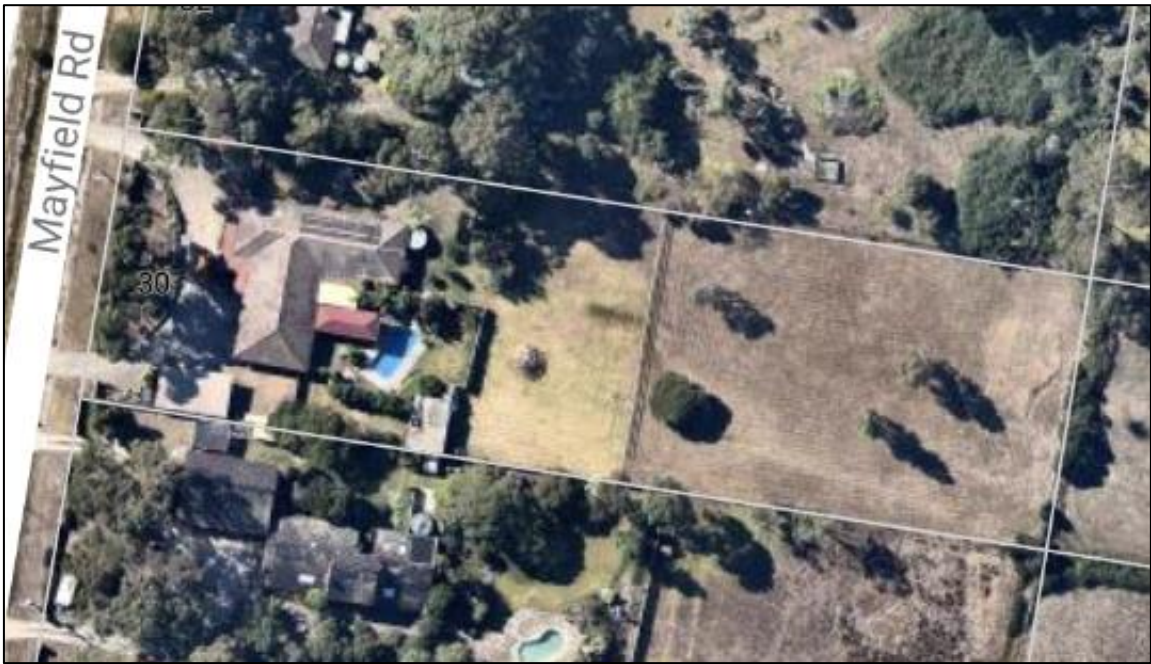
Site Description- No trees on this site are worth retaining, all are planted with a mix of native and exotic.	
Species observed on site	Native and exotic
Approx. age of larger trees on site	NA
Approx. tree heights	NA
Significant trees	No
Any habitat hollows observed	No
Is further targeted assessment required on this site	No

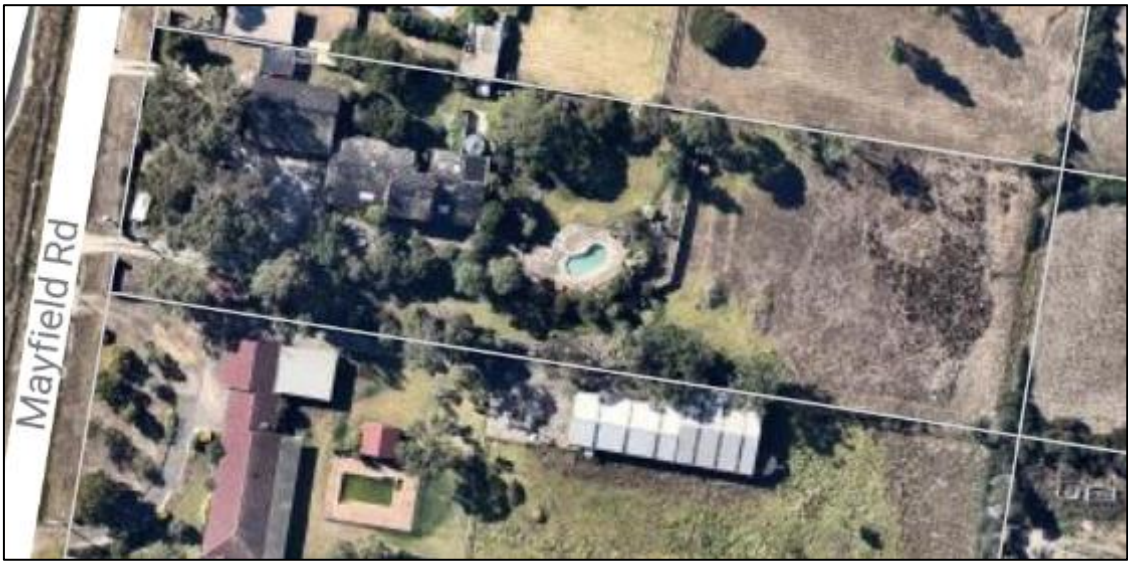
Site Description- Dense Eucalypt plantings within the front setback. These trees are all planted and no trees are considered to be remnant.	
Species observed on site	Native and exotic
Approx. age of larger trees on site	Semi mature
Approx. tree heights	10 metres
Significant trees	No
Any habitat hollows observed	No
Is further targeted assessment required on this site	No

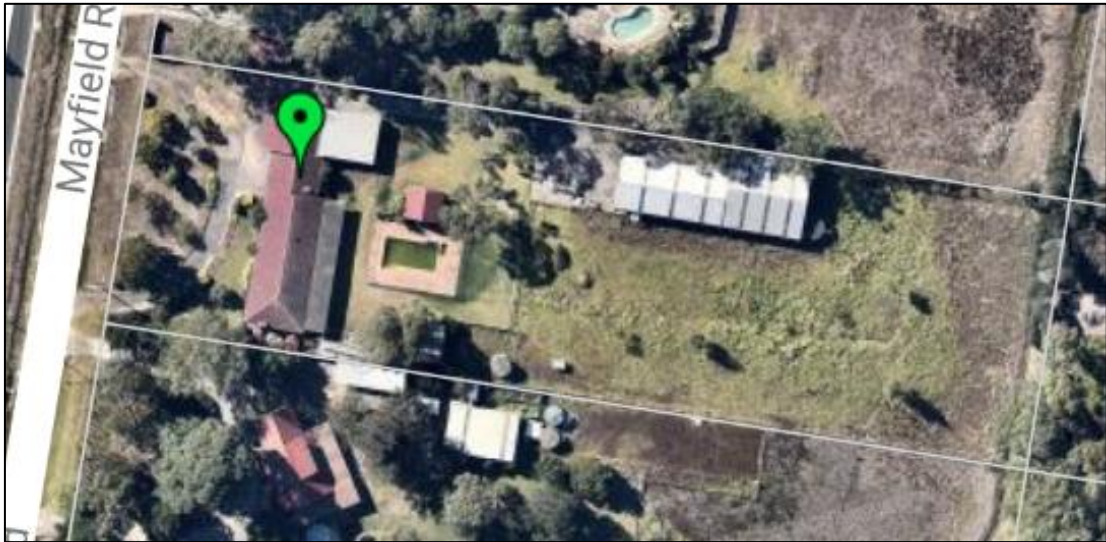
Site Description- Young native and exotic plantings are growing within the front setback of the property. No significant vegetation on site.	
Species observed on site	Native and exotic
Approx. age of larger trees on site	NA
Approx. tree heights	NA
Significant trees	No
Any habitat hollows observed	No
Is further targeted assessment required on this site	No
