SUSTAINABLE TREE MANAGEMENT

PRELIMINARY TREE ASSESSMENT

Site Address:
Collison Estate, Cranbourne East

Prepared June 2018
Updated 17 May 2019

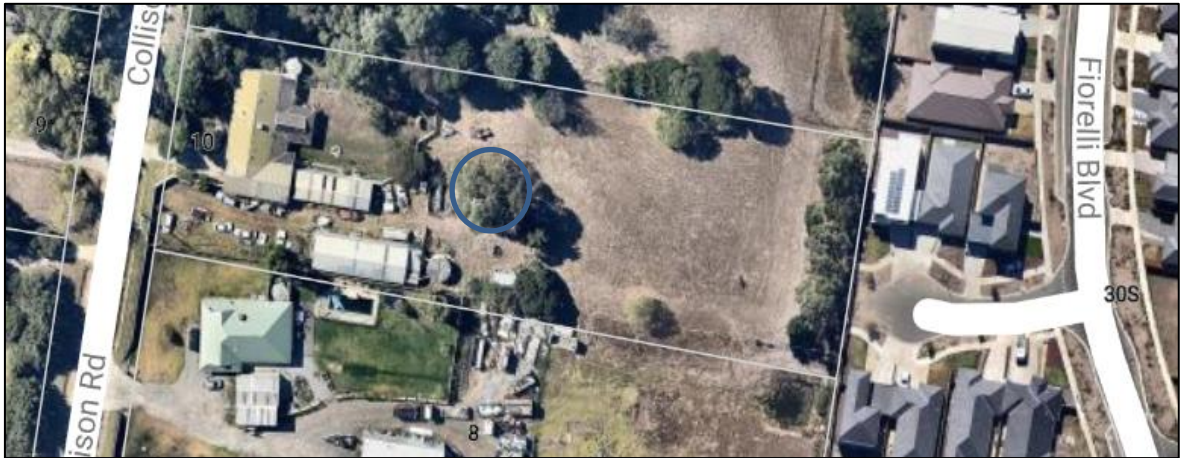
10 COLLISON ROAD, CRANBOURNE EAST

Site Description- All trees assessed within the front setback are low retention exotic and native plantings. One large and likely mature tree growing in the rear yard requires a targeted assessment. (highlighted In blue)	
Species observed on site	Native and exotic
Approx. age of larger trees on site	25 plus
Approx. tree heights	15
Significant trees	No
Any habitat hollows observed	No
Is further targeted assessment required on this site	Yes

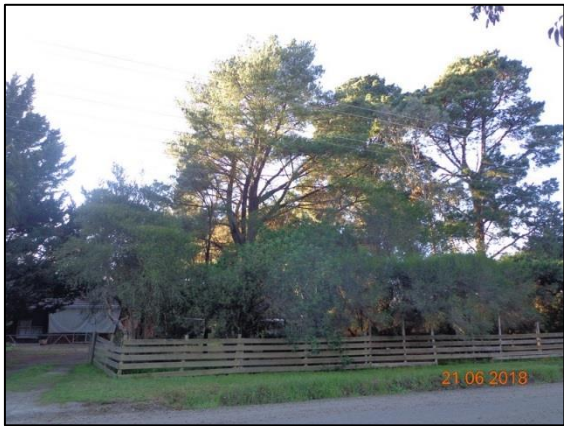
12 COLLISON ROAD, CRANBOURNE EAST

Site Description- Dense mature plantings of exotic specimens within the front setback of the property. These trees are Cypress and Pine species. No remnant native vegetation was observed.	
Species observed on site	Exotic
Approx. age of larger trees on site	10 plus
Approx. tree heights	10 metres
Significant trees	No
Any habitat hollows observed	No
Is further targeted assessment required on this site	No

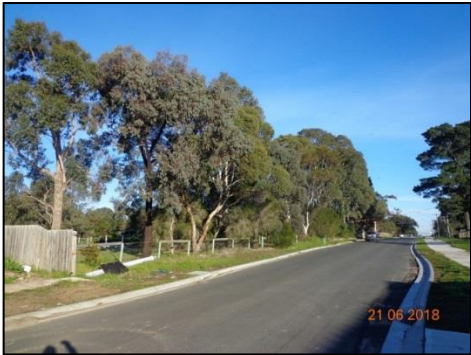
Site Description- This site is dominated by semi mature and mature Eucalyptus sp. The majority of the trees on this site look to be around 30- 40 years old although there are many trees growing in the rear yard that couldn't be accessed. A targeted assessment of trees on this site should be undertaken prior to making a final determination regarding tree removal. Image below shows native trees growing along the Heather Grove frontage.

Species observed on site	Eucalypt varieties
Approx. age of larger trees on site	30-40 years
Approx. tree heights	15 metres
Significant trees	No
Any habitat hollows observed	No
Is further targeted assessment required on this site	Yes- Targeted site visit

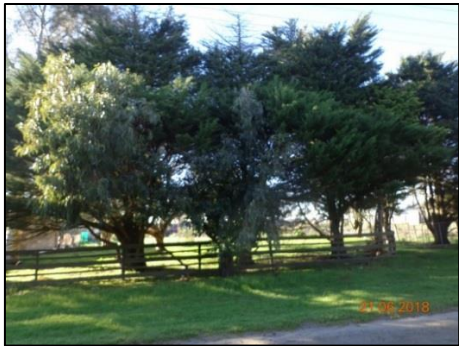
24 COLLISON ROAD, CRANBOURNE EAST

Site Description- Front setback of 24 Collison Road is dominated by exotic plantings. No remnant native vegetation was observed and no further targeted site assessments are required. The street tree growing within the road reserve is a topped *Eucalyptus sp* that is growing directly under HV wires and has poor structure.

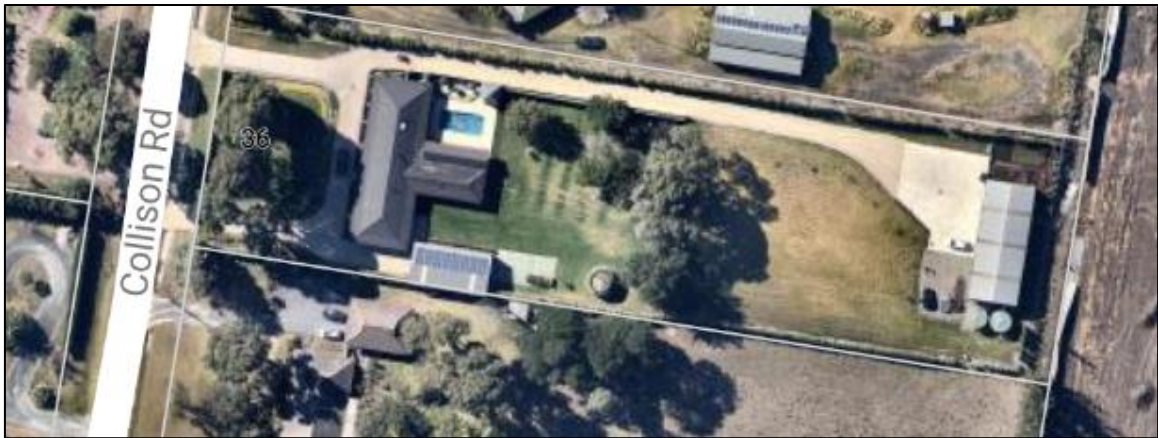
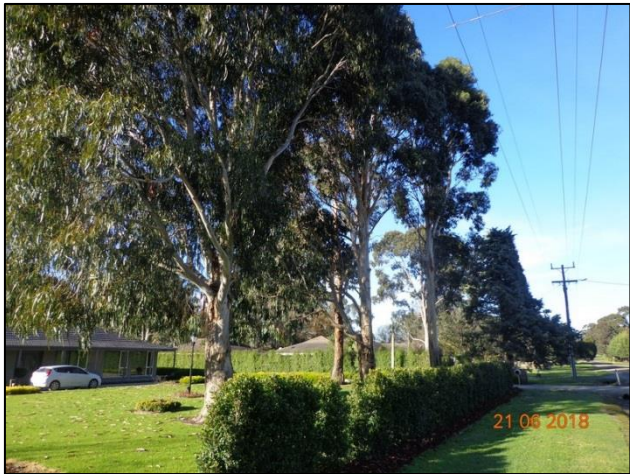
36 COLLISON ROAD, CRANBOURNE EAST

Site Description- Four Blue Gums are growing within the front setback of the property. These trees have been likely planted to provide screening from the road and are approximately 30 years old. No remnant vegetation was observed on site.

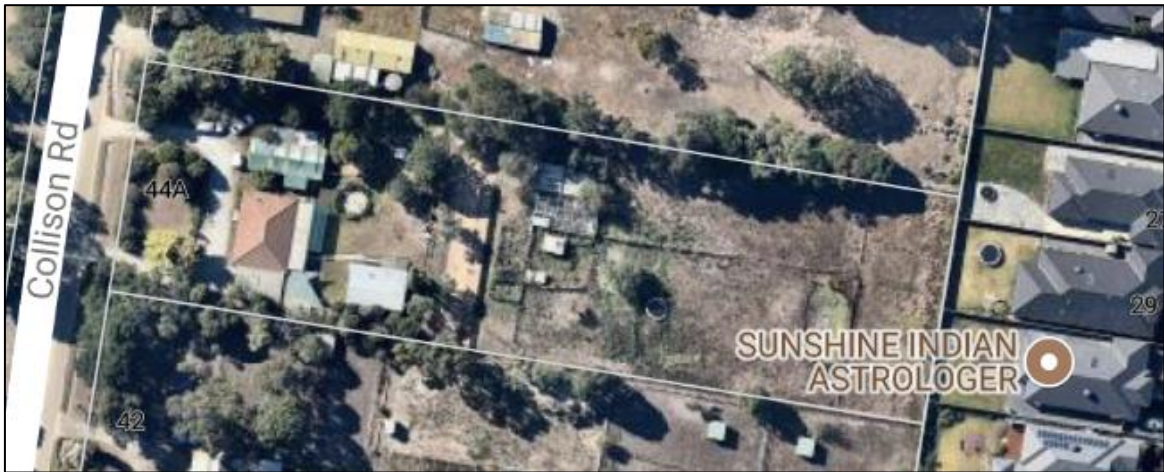
44 COLLISON ROAD, CRANBOURNE EAST

Site Description- The site is made up of a mix of native of exotic planting with the majority found within the front setback. No trees were assessed over 20 years old and no further targeted assessments are required.

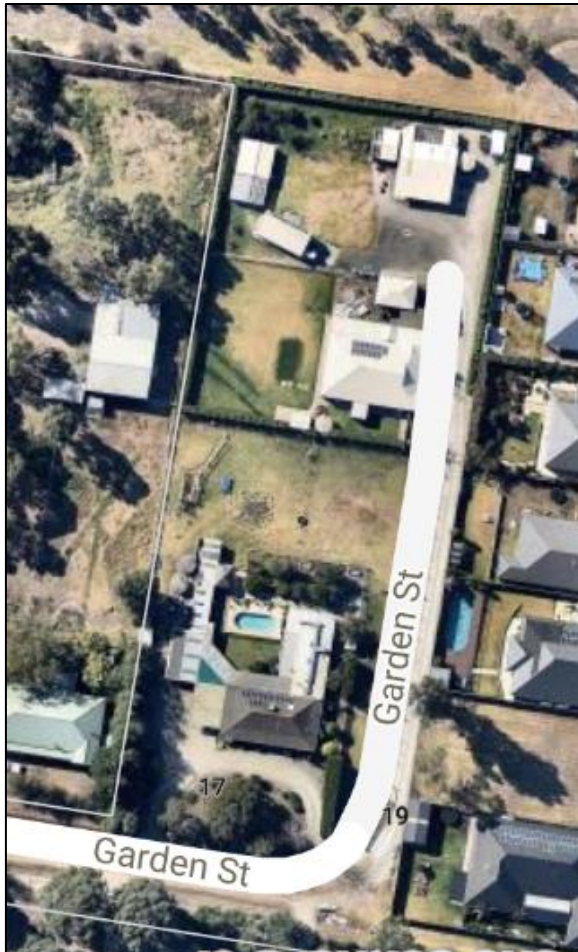
17 & 19 GARDEN STREET, CRANBOURNE EAST

Site Description- The subdivided site has been planted out with native and exotic specimens. No trees on either site are semi mature in age. No further assessment is required.

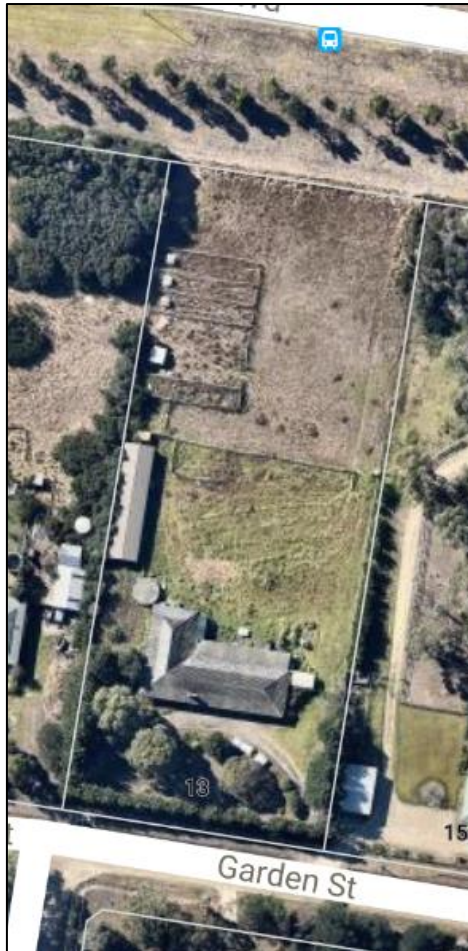
13 GARDEN STREET, CRANBOURNE EAST

Site Description- Cypress trees growing along the frontage. Low retention native and exotic plantings elsewhere on the site. No mature vegetation observed.

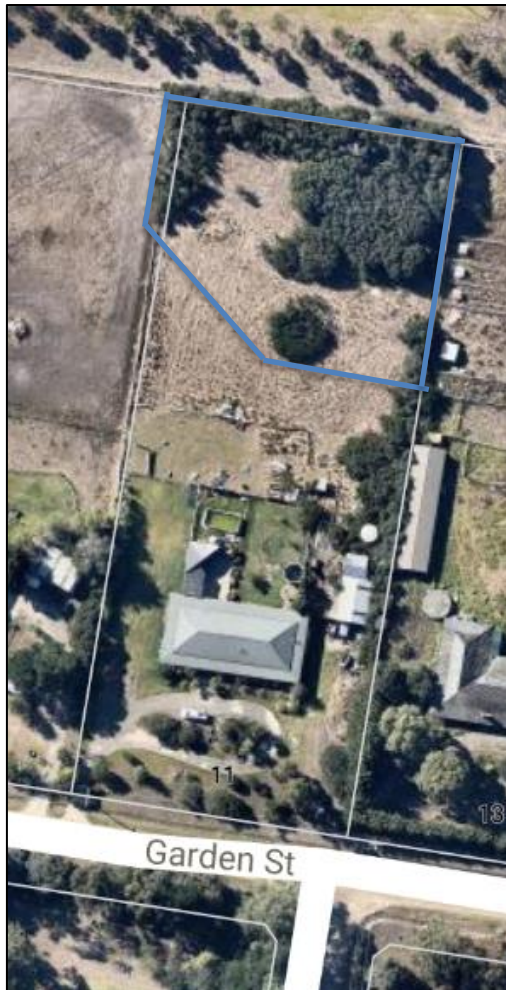
11 GARDEN STREET, CRANBOURNE EAST

Site Description- Young and semi mature plantings are growing within the front setback. Native Swamp Melaleuca (regrowth) growing in the rear yard requires a targeted assessment as it may be over 10 years old. This area has been highlighted in blue.

Species observed on site	Native and exotic
Approx. age of larger trees on site	NA
Approx. tree heights	NA
Significant trees	No
Any habitat hollows observed	No
Is further targeted assessment required on this site	Yes (regrowth in rear yard)

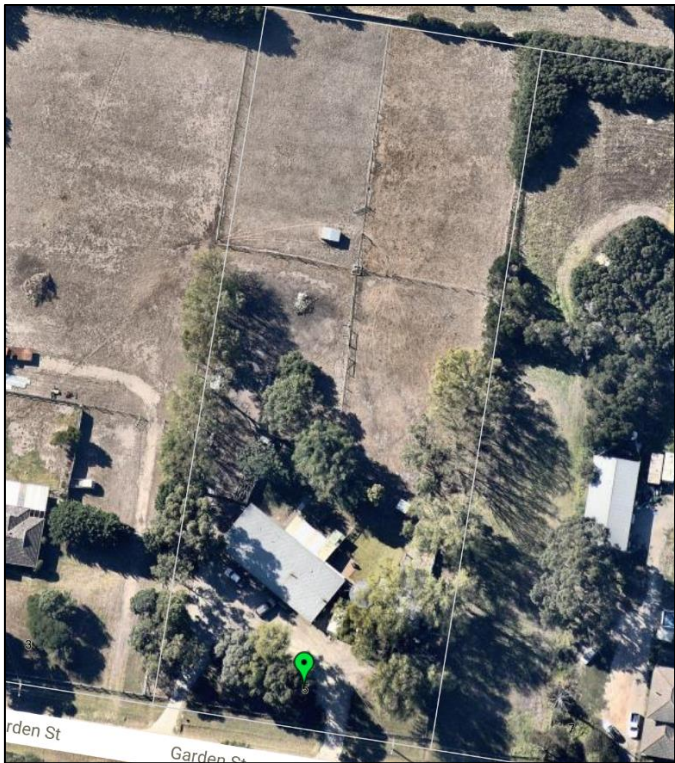
5 GARDEN STREET, CRANBOURNE EAST

Site Description- Trees growing within the front setback are semi mature natives. Trees growing along the eastern boundary are exotic <i>Salix sp.</i> No trees observed are remnant and no further investigation is required.	
Species observed on site	Native and exotic
Approx. age of larger trees on site	Semi mature
Approx. tree heights	10-15 metres
Significant trees	No
Any habitat hollows observed	No
Is further targeted assessment required on this site	No

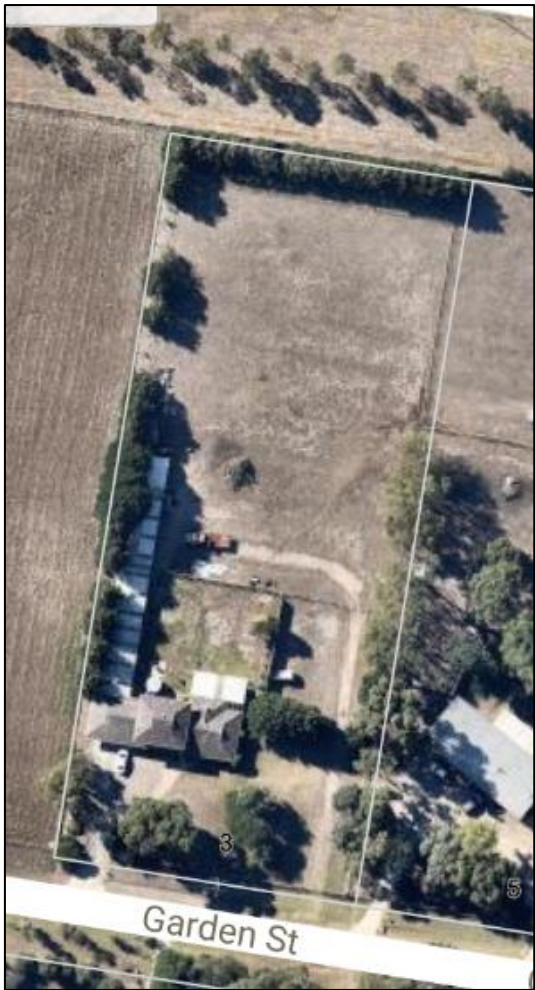
3 GARDEN STREET, CRANBOURNE EAST

Site Description- One semi mature eucalypt is growing in the front setback. The majority of vegetation on site is planted exotics. No further targeted assessment is required.	
Species observed on site	Native and exotic
Approx. age of larger trees on site	Semi mature
Approx. tree heights	NA
Significant trees	No
Any habitat hollows observed	No
Is further targeted assessment required on this site	No

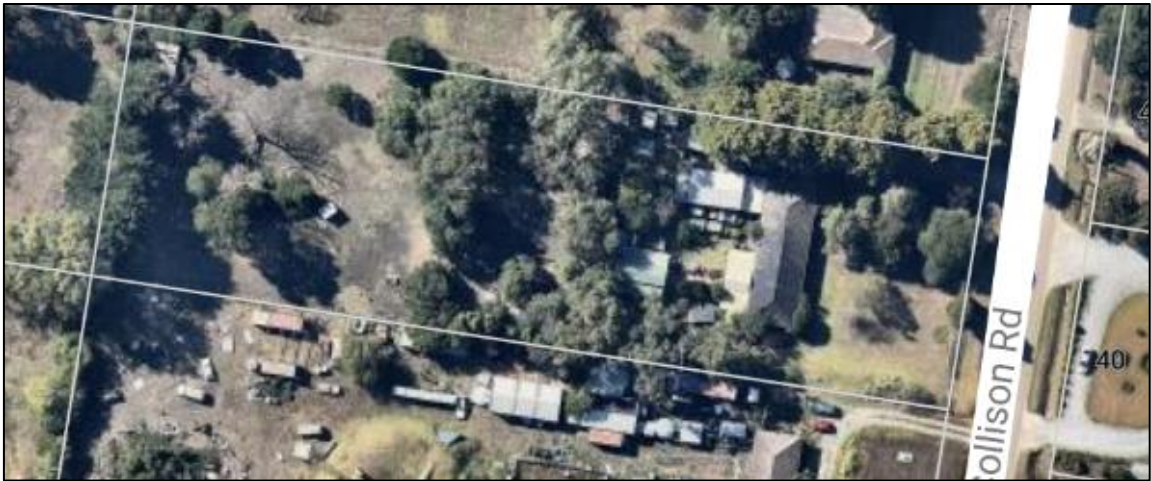
41 COLLISON ROAD, CRANBOURNE EAST

Site Description- Planted Eucalypt trees are growing along the southern boundary. Exotic Cypress trees are growing along the northern boundary.	
Species observed on site	Native and exotic
Approx. age of larger trees on site	Semi mature/mature
Approx. tree heights	13 metres
Significant trees	No
Any habitat hollows observed	No
Is further targeted assessment required on this site	No

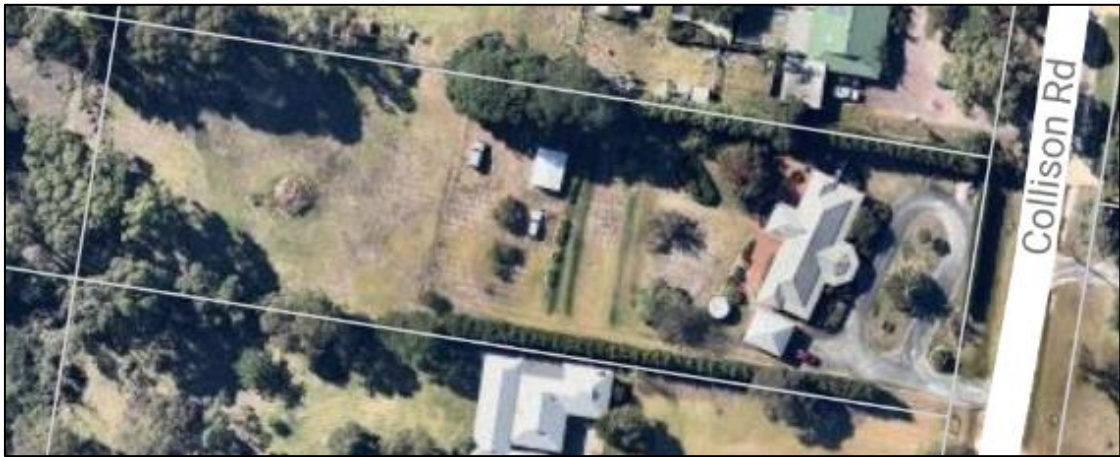
35 COLLISON ROAD, CRANBOURNE EAST

Site Description- The front setback has been planted out with exotic specimens. No native trees observed within the rear yard are mature.

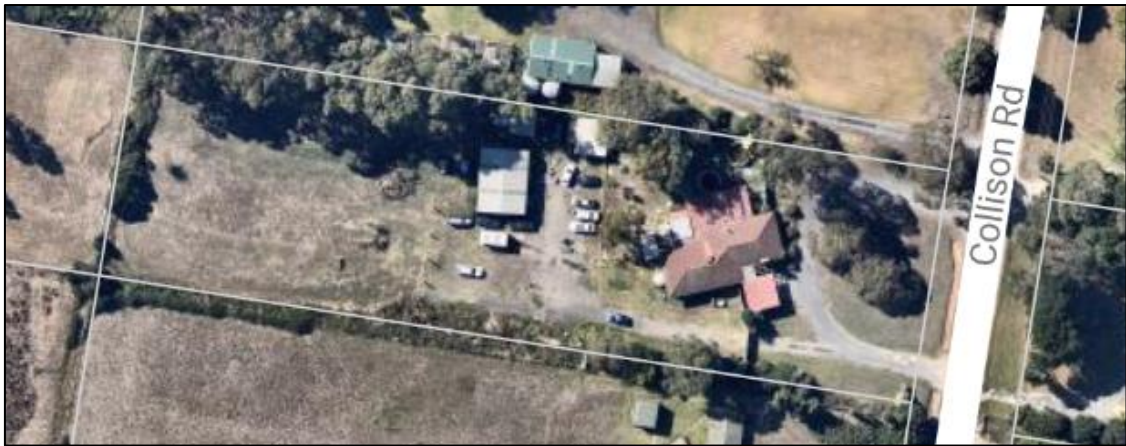
31 COLLISON ROAD, CRANBOURNE EAST

Site Description- All native tree growing along the northern boundary have been assessed as planted vegetation.	
Species observed on site	Native and exotic
Approx. age of larger trees on site	25 years
Approx. tree heights	15 metres
Significant trees	No
Any habitat hollows observed	No
Is further targeted assessment required on this site	No

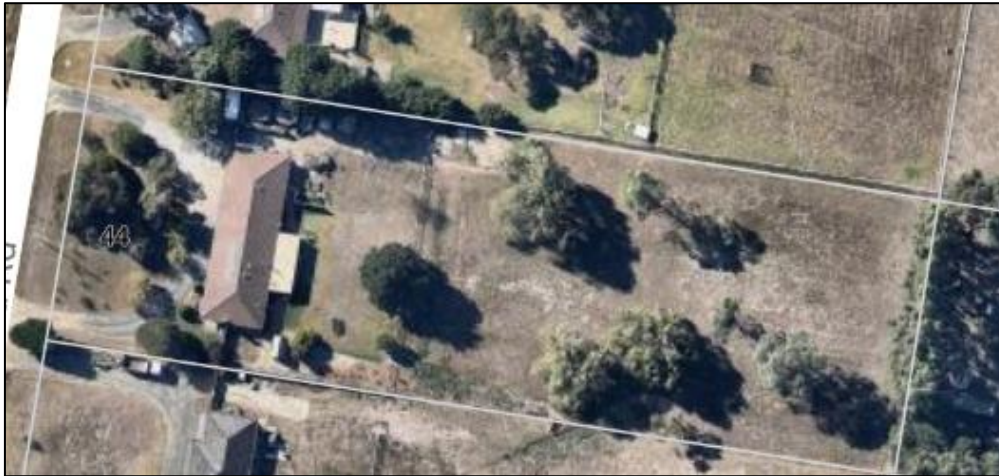
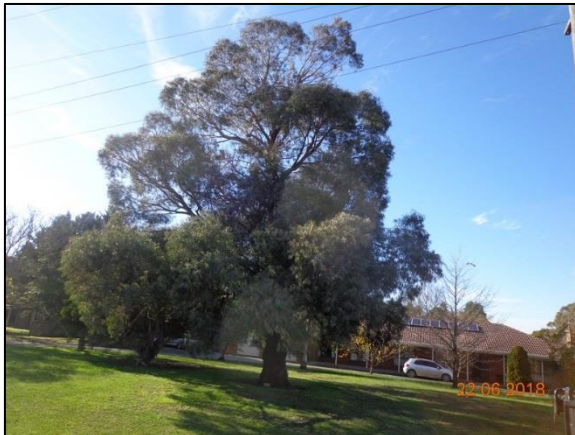
44 MAYFIELD ROAD, CRANBOURNE EAST

Site Description- Mature *Eucalyptus sp* growing within the front setback. Larger trees in the rear yard are exotic.

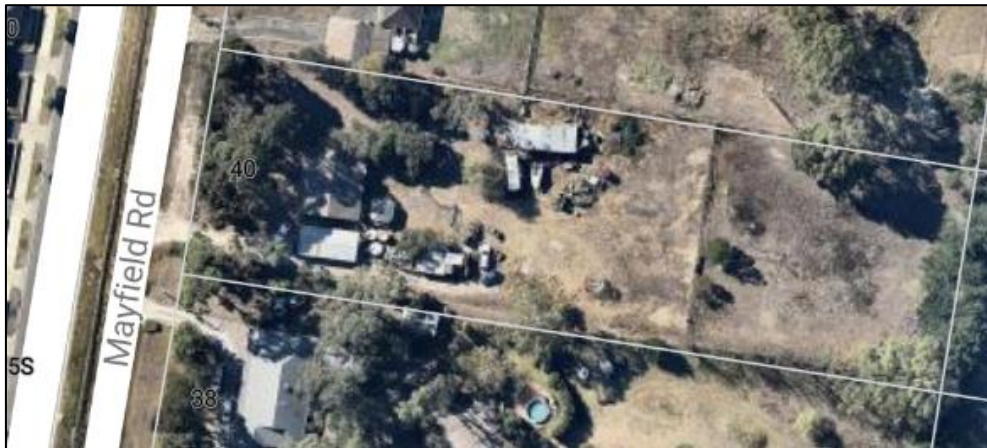
40 MAYFIELD ROAD, CRANBOURNE EAST

Site Description- Dense native plantings within the front setback of the property. No trees over 25 years old were observed growing within the front setback. Number 40, 38, 36, 34 and 32 Mayfair Road have dense vegetation plantings and each site is side by side. Further targeted tree assessments of these sites is recommended.

Species observed on site	Native
Approx. age of larger trees on site	15-25 years
Approx. tree heights	10-12 metres
Significant trees	No
Any habitat hollows observed	No
Is further targeted assessment required on this site	Yes

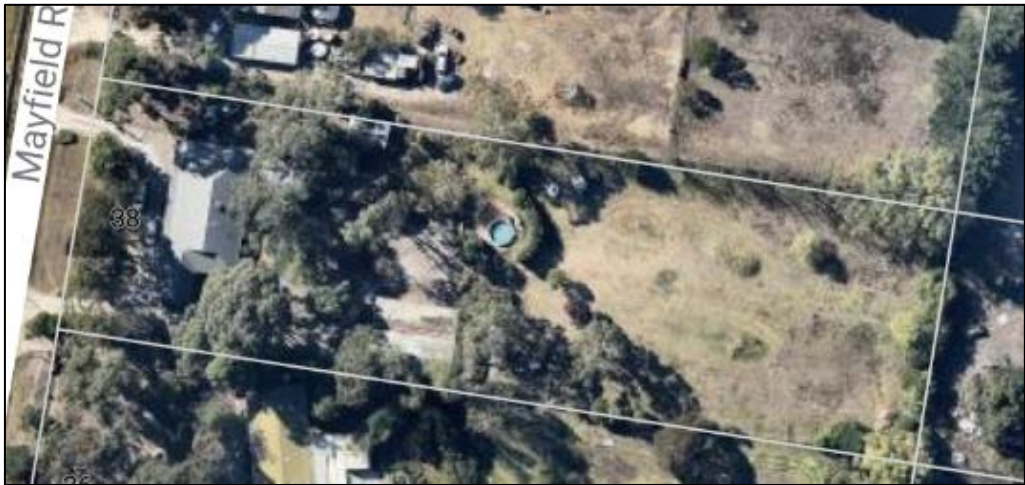
38 MAYFIELD ROAD, CRANBOURNE EAST

Site Description- Semi mature and mature native plantings were observed within the front setback of the property. No trees on site are assessed as remnant. Number 40, 38, 36, 34 and 32 Mayfair Road have dense vegetation plantings and each site is side by side. Further targeted tree assessments of these sites is recommended.	
Species observed on site	Native and exotic
Approx. age of larger trees on site	20-30 years
Approx. tree heights	10 -15 metres
Significant trees	No
Any habitat hollows observed	No
Is further targeted assessment required on this site	Yes

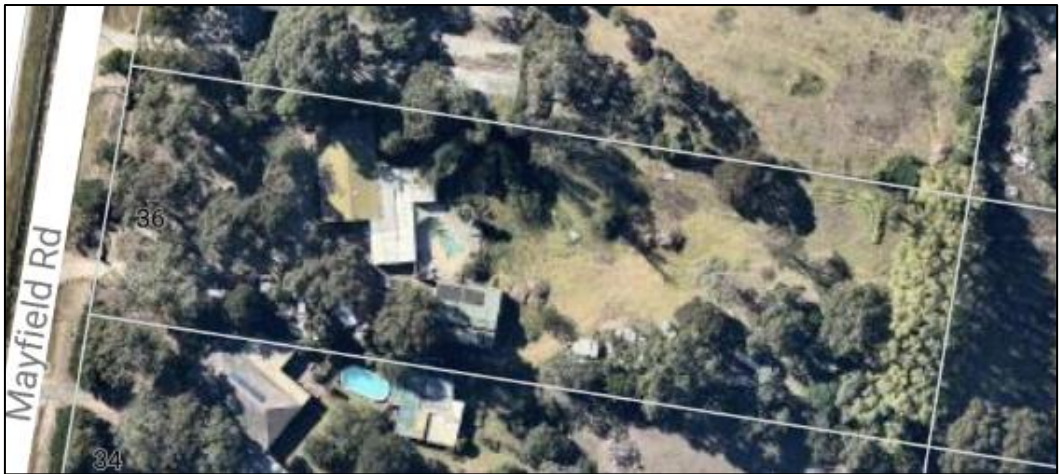
36 MAYFIELD ROAD, CRANBOURNE EAST

Site Description- Semi mature and mature native plantings were observed within the front setback of the property. No trees on site are assessed as remnant. Number 40, 38, 36, 34 and 32 Mayfair Road have dense vegetation plantings and each site is side by side. Further targeted tree assessments of these sites is recommended.	
Species observed on site	Native
Approx. age of larger trees on site	Semi mature - mature
Approx. tree heights	10-15 metres
Significant trees	No
Any habitat hollows observed	No
Is further targeted assessment required on this site	Yes

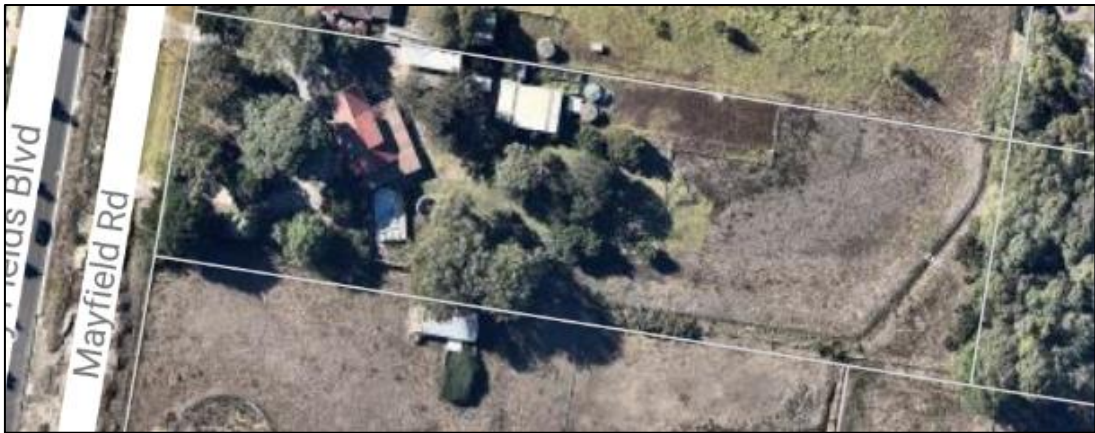
24 MAYFIELD ROAD, CRANBOURNE EAST

Site Description- The larger trees on this site that are growing within the front setback are exotic. No native vegetation on site is worth retaining.	
Species observed on site	Native and exotic
Approx. age of larger trees on site	NA
Approx. tree heights	NA
Significant trees	No
Any habitat hollows observed	No
Is further targeted assessment required on this site	No

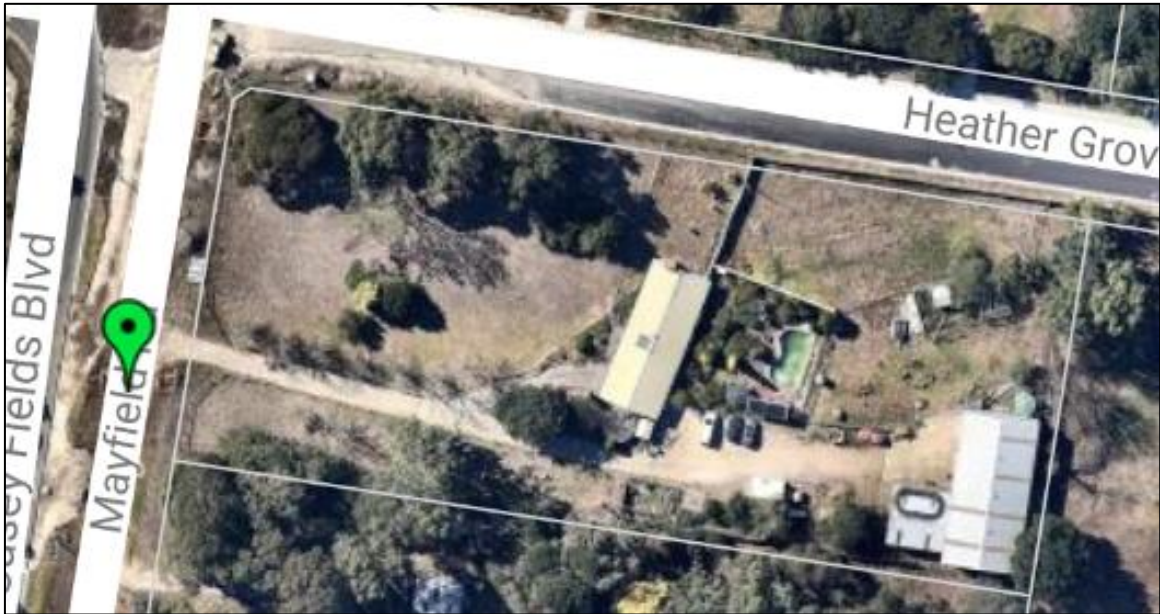
20 MAYFIELD ROAD, CRANBOURNE EAST

Site Description- Four mature Eucalypt trees growing adjacent Heather Grove. Trees are healthy in good overall condition. The four trees look to have been planted to provide screening from Heather Grove. No remnant trees were observed.	
Species observed on site	Native
Approx. age of larger trees on site	25-35 years
Approx. tree heights	12 metres plus
Significant trees	No
Any habitat hollows observed	No
Is further targeted assessment required on this site	No

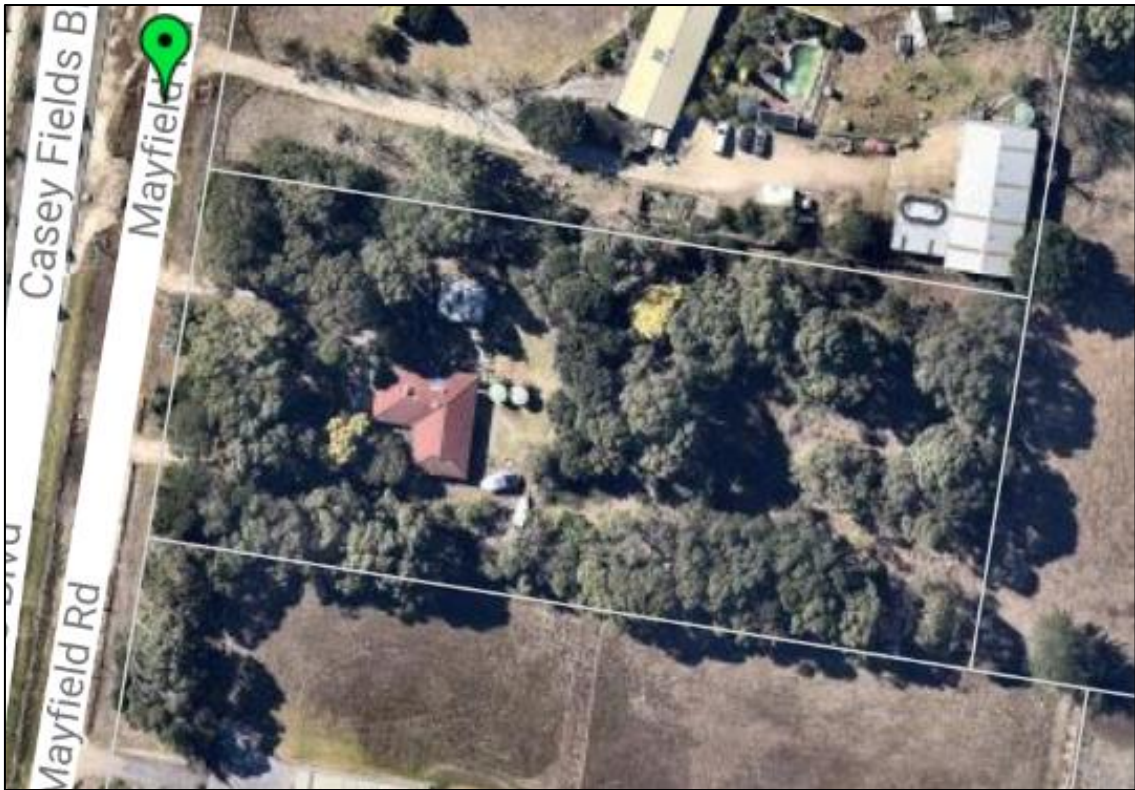
18 MAYFIELD ROAD, CRANBOURNE EAST

Site Description- Dense population of what look to be planted native and exotic trees on the site. Further targeted tree assessment of vegetation located within the rear yard is required. Unlikely to find remnant trees within the rear yard but cannot confirm.	
Species observed on site	Native and exotic
Approx. age of larger trees on site	25-35 years
Approx. tree heights	15 metres
Significant trees	No
Any habitat hollows observed	NA
Is further targeted assessment required on this site	Yes

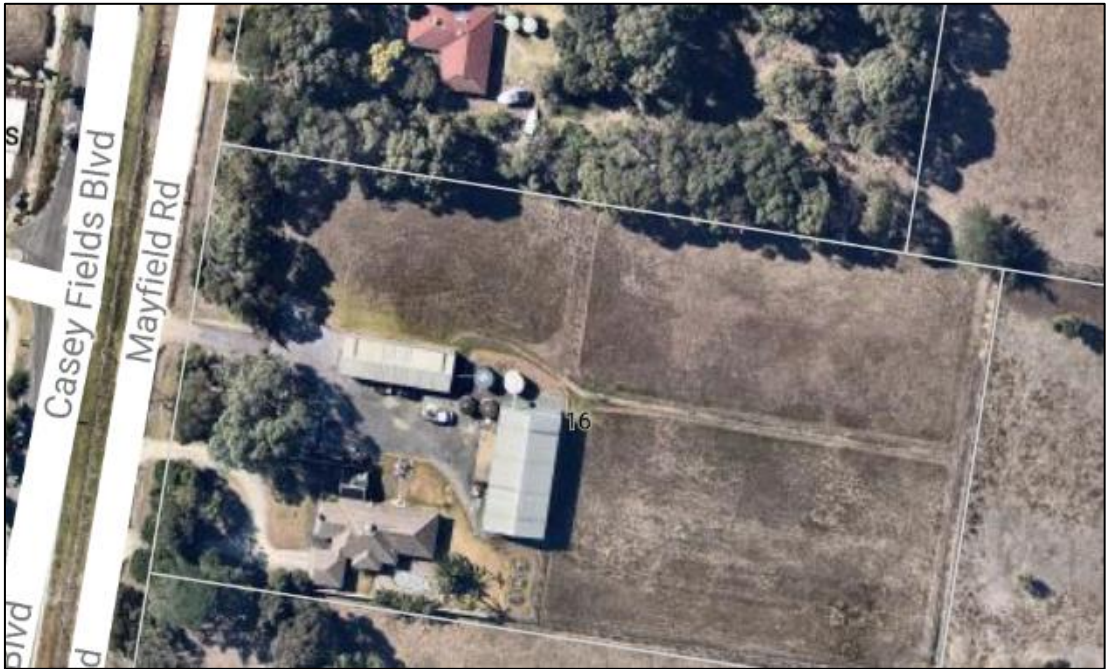
16 MAYFIELD ROAD, CRANBOURNE EAST

Site Description- All native trees growing within the front setback are planted under 25 years old. No further assessment is required.	
Species observed on site	Native and exotic
Approx. age of larger trees on site	Semi mature
Approx. tree heights	10 metres
Significant trees	No
Any habitat hollows observed	No
Is further targeted assessment required on this site	No

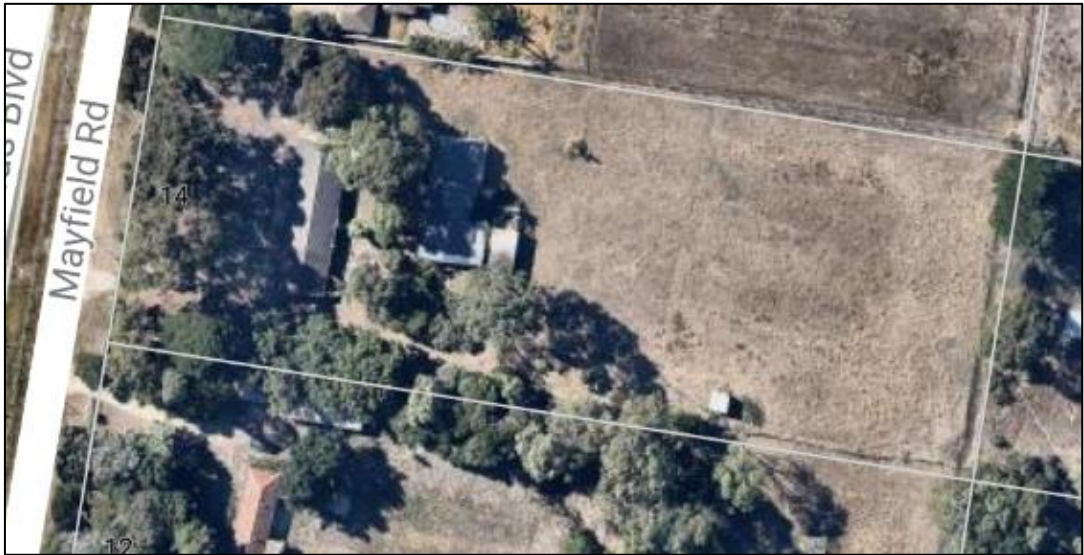
14 MAYFIELD ROAD, CRANBOURNE EAST

Site Description- All native trees growing within the front setback are planted under 25 years old. No further assessment is required.	
Species observed on site	Native and exotic
Approx. age of larger trees on site	Semi mature
Approx. tree heights	NA
Significant trees	No
Any habitat hollows observed	No
Is further targeted assessment required on this site	No

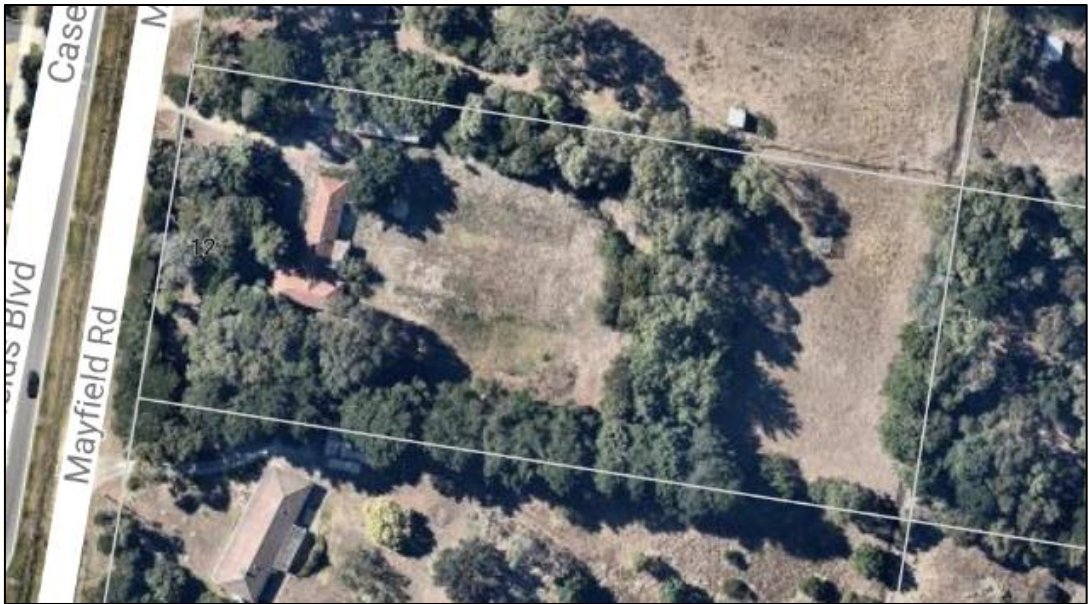
12 MAYFIELD ROAD, CRANBOURNE EAST

Site Description- All native trees growing on the property are planted under 25 years old. No further assessment is required.	
Species observed on site	Native and exotic
Approx. age of larger trees on site	Semi mature
Approx. tree heights	NA
Significant trees	No
Any habitat hollows observed	No
Is further targeted assessment required on this site	No

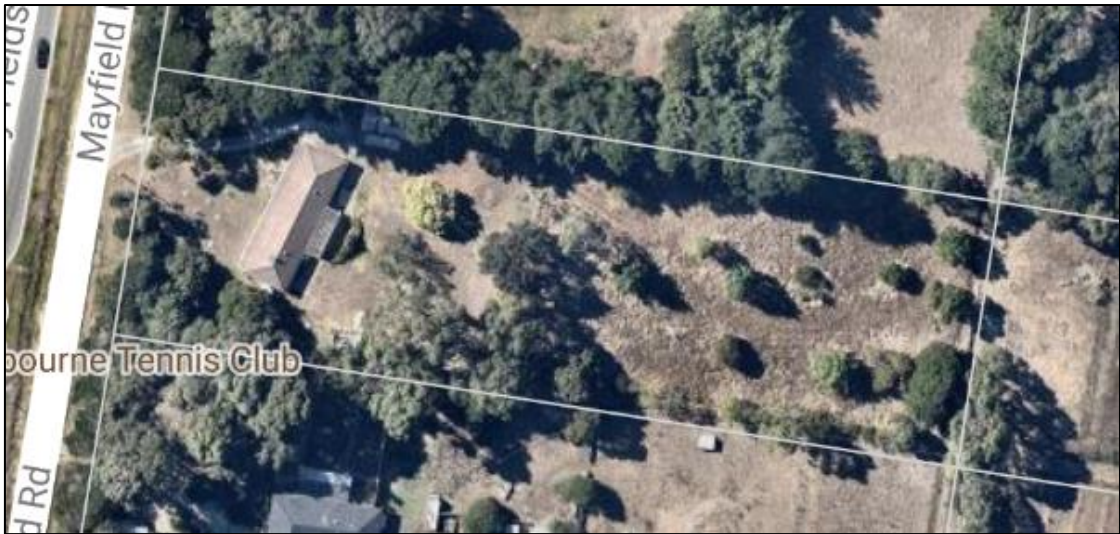
10 MAYFIELD ROAD, CRANBOURNE EAST

Site Description- All native trees growing on the property are planted under 25 years old. No further assessment is required.	
Species observed on site	Native and exotic
Approx. age of larger trees on site	Semi mature
Approx. tree heights	NA
Significant trees	No
Any habitat hollows observed	No
Is further targeted assessment required on this site	No

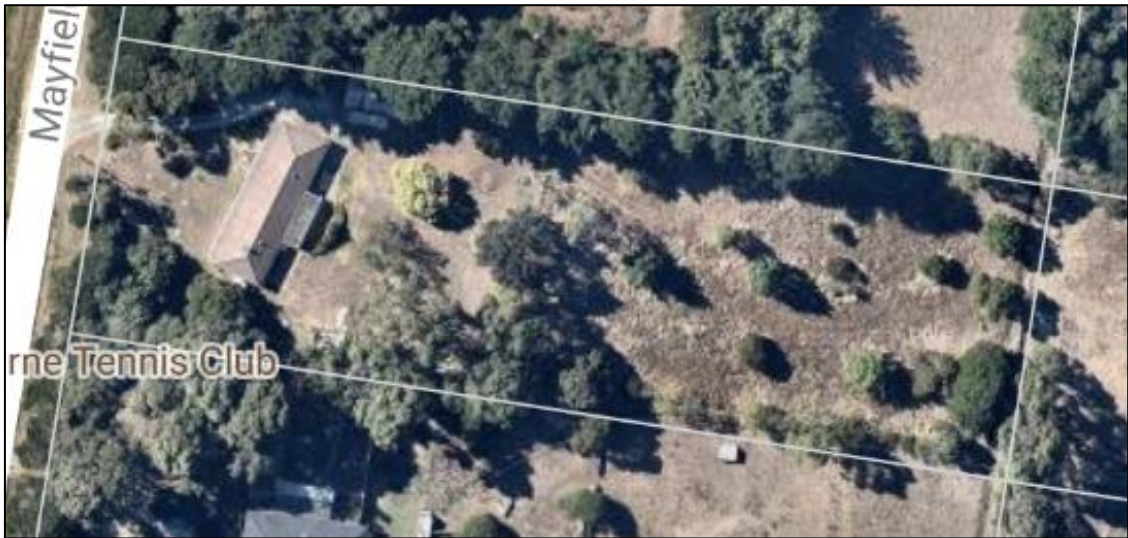
8 MAYFIELD ROAD, CRANBOURNE EAST

Site Description- All native trees growing on the property are planted under 25 years old. No further assessment is required. No mature native vegetation was observed.	
Species observed on site	Native and exotic
Approx. age of larger trees on site	Semi mature
Approx. tree heights	NA
Significant trees	No
Any habitat hollows observed	No
Is further targeted assessment required on this site	No

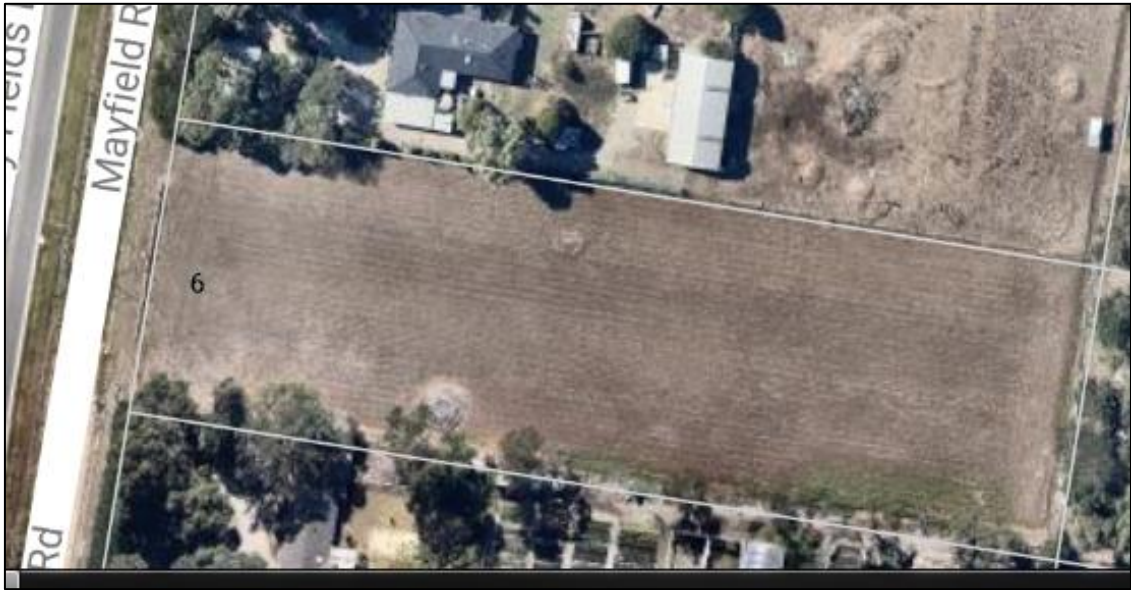
6 MAYFIELD ROAD, CRANBOURNE EAST

Site Description- No trees are growing on site.	
Species observed on site	NA
Approx. age of larger trees on site	NA
Approx. tree heights	NA
Significant trees	NA
Any habitat hollows observed	NA
Is further targeted assessment required on this site	NA

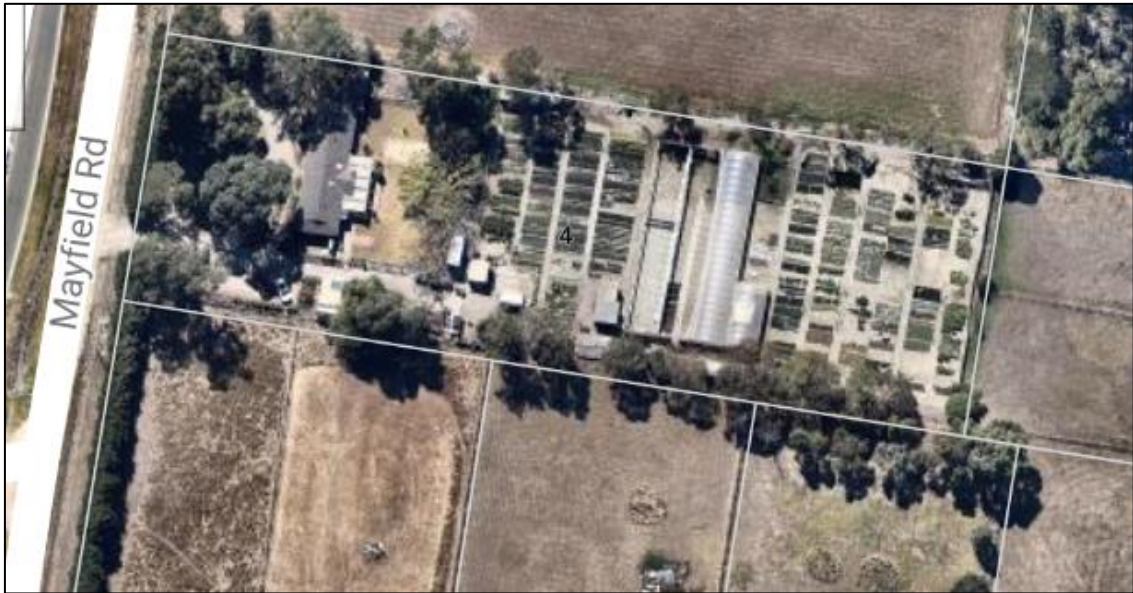
4 MAYFIELD ROAD, CRANBOURNE EAST

Site Description- All native trees growing within the front setback of the property are planted under 25 years old. No further assessment is required.	
Species observed on site	Native and exotic
Approx. age of larger trees on site	<25 years
Approx. tree heights	10 metres
Significant trees	No
Any habitat hollows observed	No
Is further targeted assessment required on this site	No

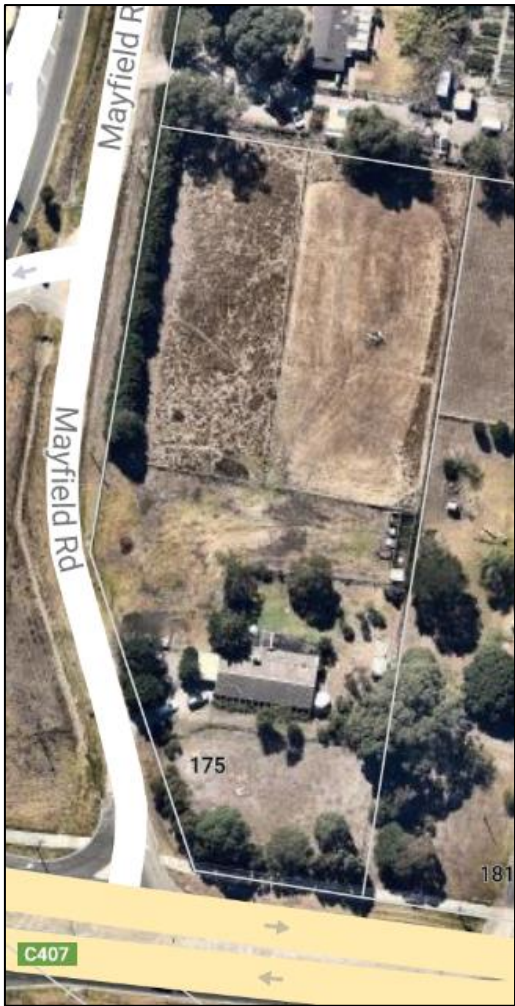
175 BERWICK CRANBOURNE ROAD, CRANBOURNE EAST

Site Description- Semi mature native trees are growing within the front setback of the property adjacent Berwick Cranbourne Road. None of these trees are assessed as being mature or significant.	
Species observed on site	Native and exotic
Approx. age of larger trees on site	<25 years
Approx. tree heights	10 metres
Significant trees	No
Any habitat hollows observed	No
Is further targeted assessment required on this site	No

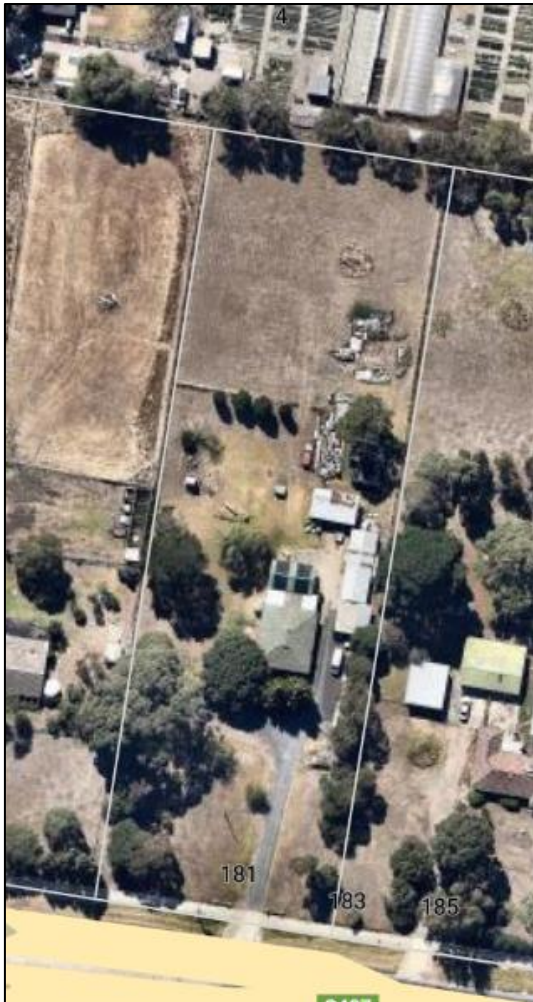
181 BERWICK CRANBOURNE ROAD, CRANBOURNE EAST

Site Description- Semi mature native trees are growing within the front setback of the property adjacent Berwick Cranbourne Road. Larger trees on site are exotic. None of these trees are assessed as being mature or significant.

Species observed on site	Native and exotic
Approx. age of larger trees on site	<25 years
Approx. tree heights	10 metres
Significant trees	No
Any habitat hollows observed	No
Is further targeted assessment required on this site	No

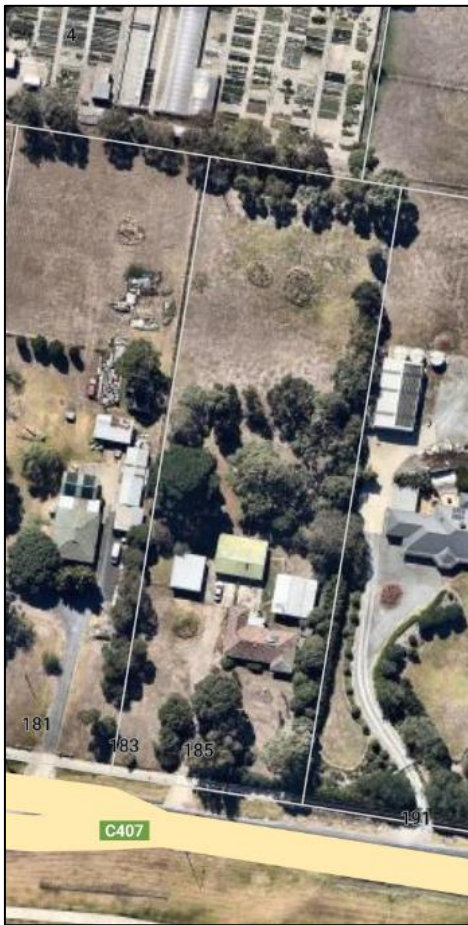
185 BERWICK CRANBOURNE ROAD, CRANBOURNE EAST

Site Description- Semi mature native trees are growing within the front setback of the property adjacent Berwick Cranbourne Road. Larger trees on site are exotic. None of these trees are assessed as being mature or significant.	
Species observed on site	Native and exotic
Approx. age of larger trees on site	<25 years
Approx. tree heights	10 metres
Significant trees	No
Any habitat hollows observed	No
Is further targeted assessment required on this site	No

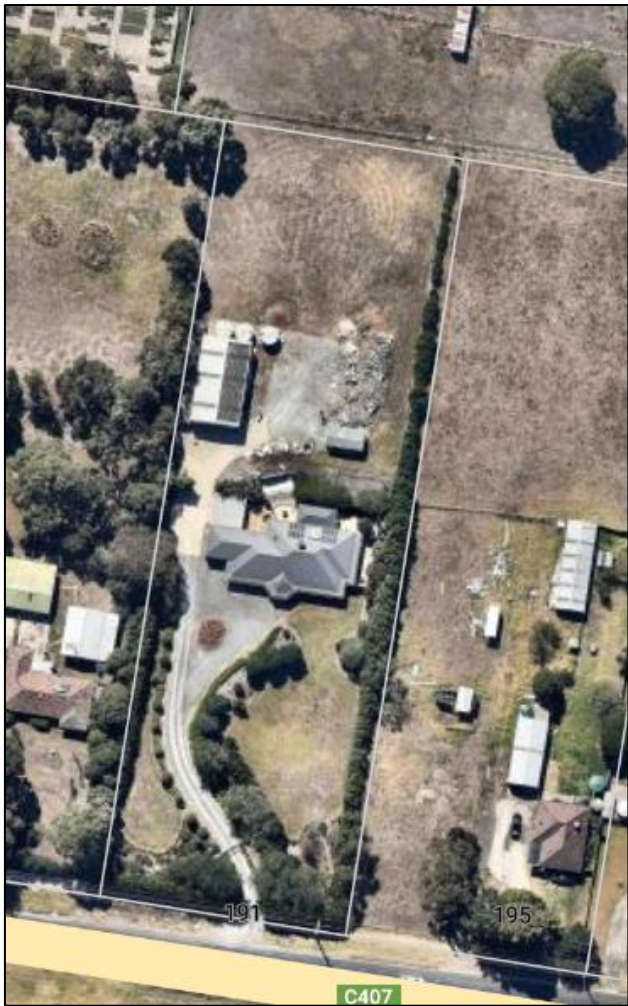
191 BERWICK CRANBOURNE ROAD, CRANBOURNE EAST

Site Description- No semi mature natives observed on site. Site has been planted out with exotics specimens.	
Species observed on site	Exotic
Approx. age of larger trees on site	NA
Approx. tree heights	NA
Significant trees	No
Any habitat hollows observed	No
Is further targeted assessment required on this site	No

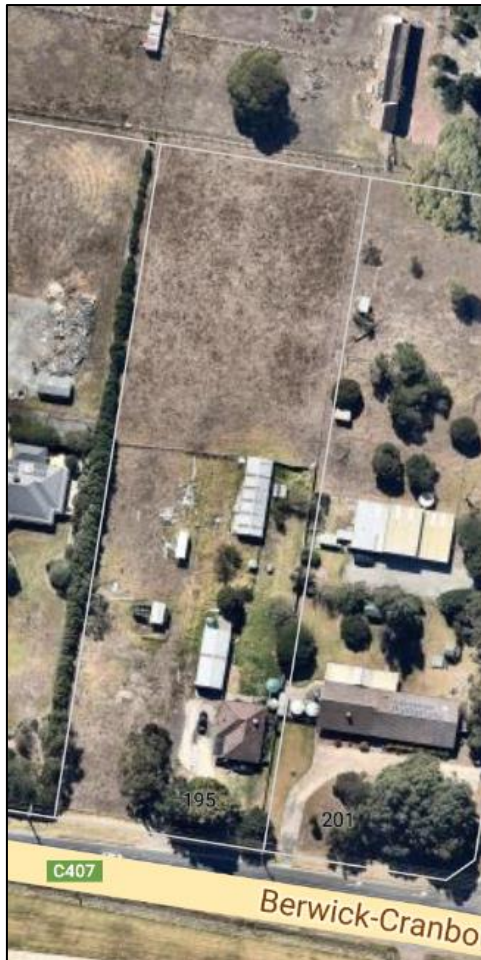
195 BERWICK CRANBOURNE ROAD, CRANBOURNE EAST

Site Description- No mature native trees exist on site.

Species observed on site	Native and exotic
Approx. age of larger trees on site	NA
Approx. tree heights	NA
Significant trees	No
Any habitat hollows observed	NA
Is further targeted assessment required on this site	NA

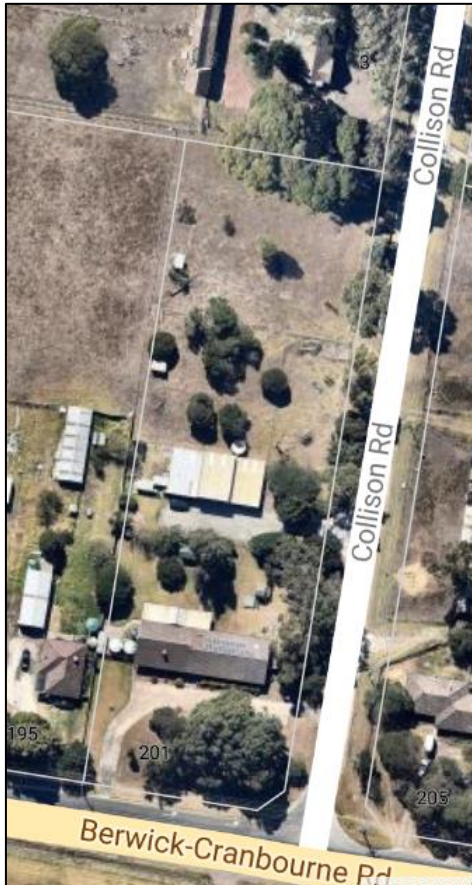
201 BERWICK CRANBOURNE ROAD, CRANBOURNE EAST

Site Description- All native vegetation growing within the front setback of the property is planted. No remnant vegetation observed on site. Seven native street trees have been planted adjacent to Collision Road.	
Species observed on site	Native and exotic
Approx. age of larger trees on site	25 years
Approx. tree heights	12 metres
Significant trees	No
Any habitat hollows observed	No
Is further targeted assessment required on this site	No

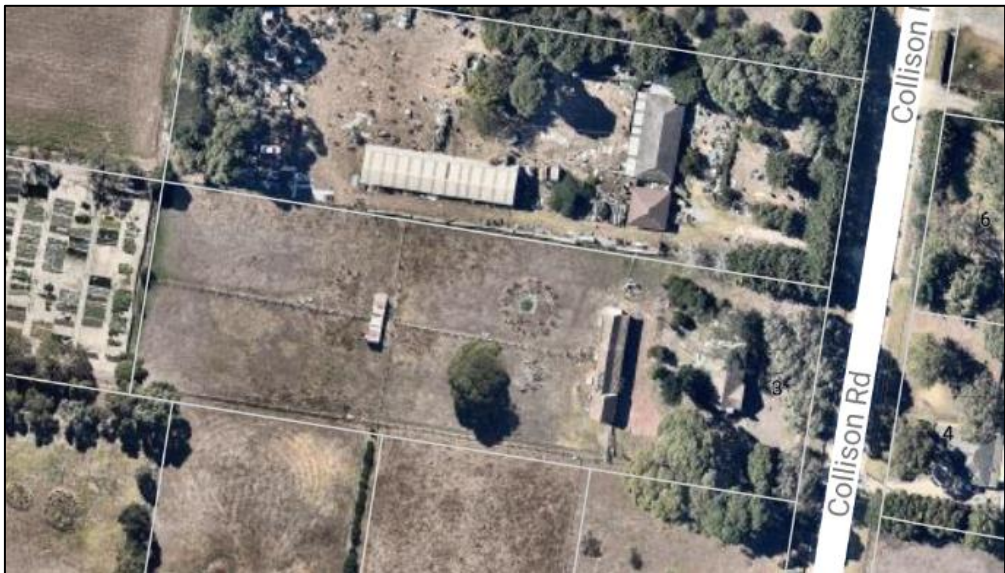
3 COLLISON ROAD, CRANBOURNE EAST

Site Description- Native vegetation growing within the front setback of the property is approximately 25 years old. No remnant vegetation was observed.	
Species observed on site	Native
Approx. age of larger trees on site	25 years
Approx. tree heights	10-15 metres
Significant trees	No
Any habitat hollows observed	No
Is further targeted assessment required on this site	No
