SUSTAINABLE TREE MANAGEMENT

PRELIMINARY TREE ASSESSMENT

Site Address:
Collison Estate, Cranbourne East

Prepared June 2018
Updated 17 May 2019

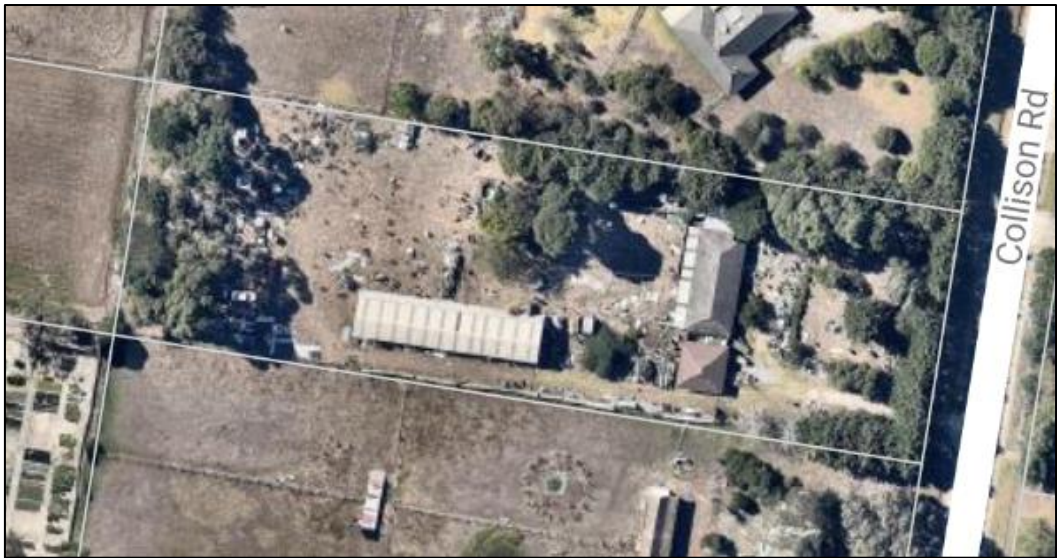
5 COLLISON ROAD, CRANBOURNE EAST

Site Description- Larger mature natives are growing within the rear yard of the property. Not able to view and identify these trees from the roadside. A further targeted assessment of these trees are growing in the rear yard.	
Species observed on site	Native
Approx. age of larger trees on site	25 years
Approx. tree heights	10-15 metres
Significant trees	NA
Any habitat hollows observed	NA
Is further targeted assessment required on this site	Yes

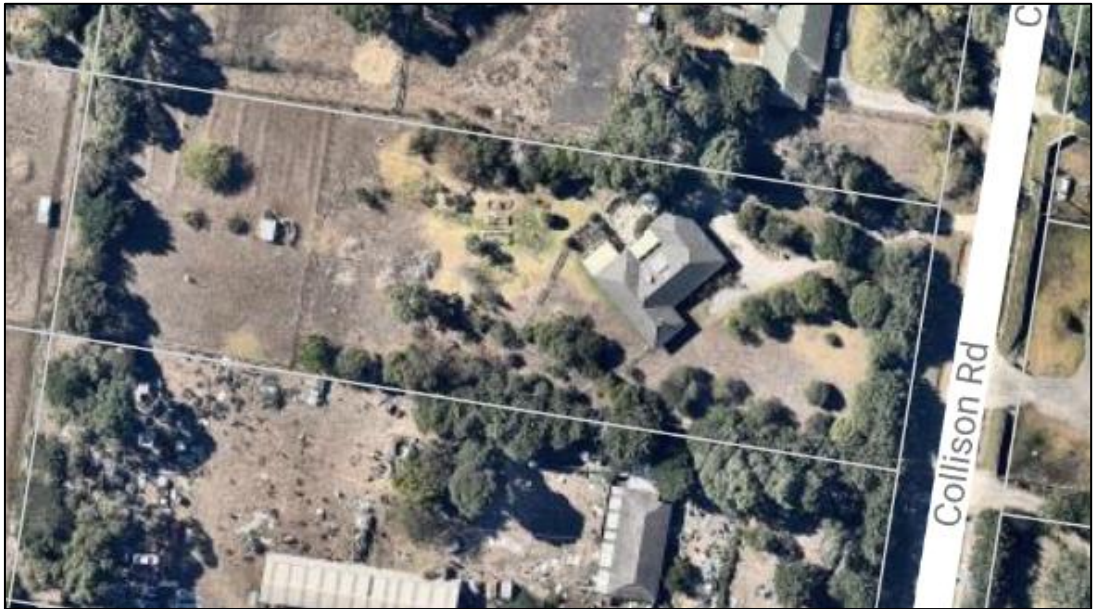
7 COLLISON ROAD, CRANBOURNE EAST

Site Description- All vegetation growing in the front setback is exotic. No other mature native trees was observed on site.	
Species observed on site	Native and exotic
Approx. age of larger trees on site	15 years
Approx. tree heights	5-10 metres
Significant trees	No
Any habitat hollows observed	No
Is further targeted assessment required on this site	No

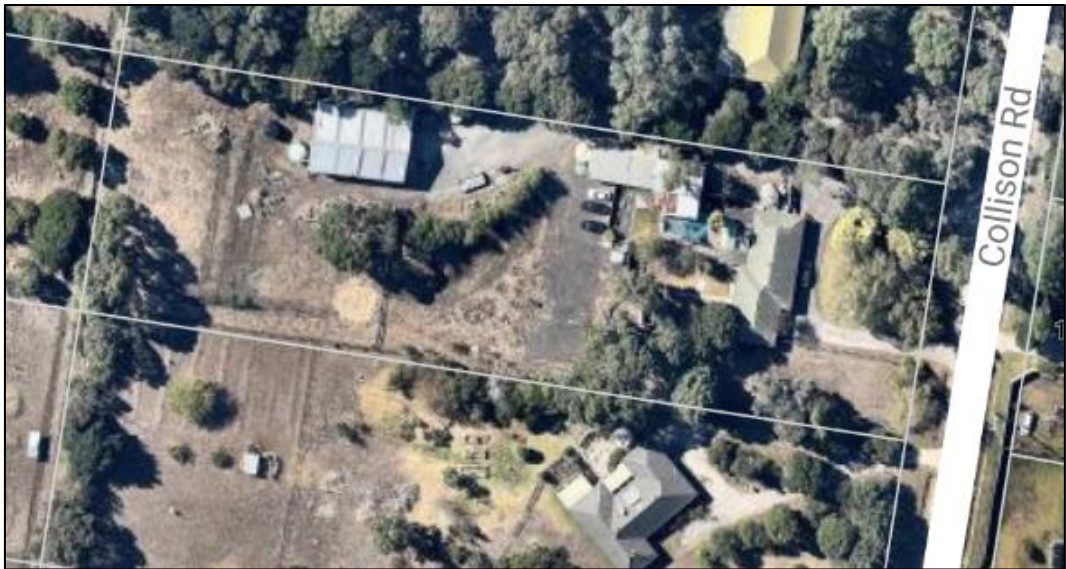
9 COLLISON ROAD, CRANBOURNE EAST

Site Description- Majority of vegetation growing onsite is exotic. Mature Eucalypt growing within the front setback. No other mature native trees was observed on site. Two street trees are not remnant.	
Species observed on site	Native and exotic
Approx. age of larger trees on site	20-25 years
Approx. tree heights	10-15 metres
Significant trees	No
Any habitat hollows observed	No
Is further targeted assessment required on this site	No

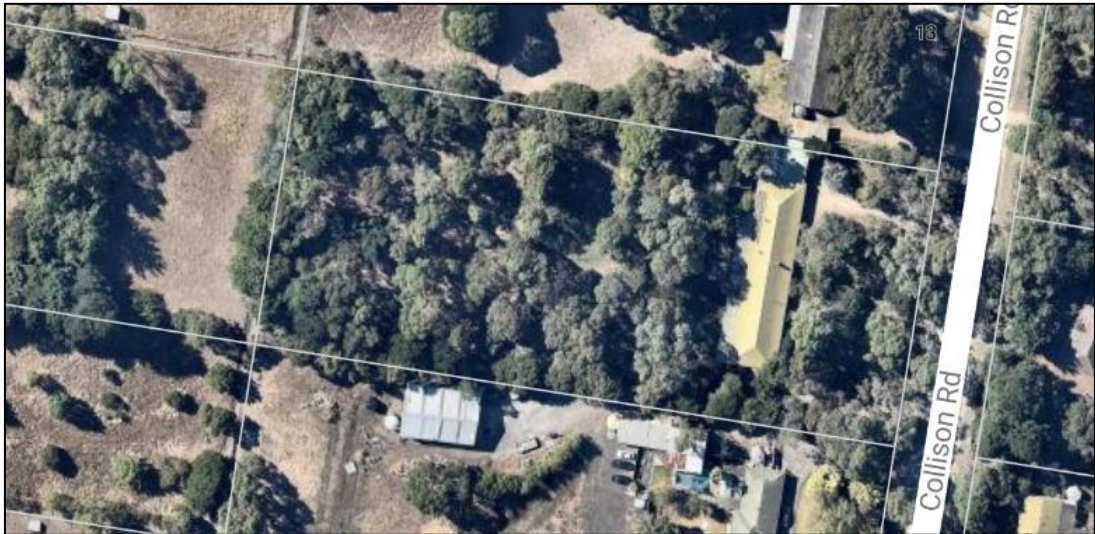
11 COLLISON ROAD, CRANBOURNE EAST

Site Description- Due to the dense population of native trees on site I was not able to view trees within the rear yard from the road side. A number of large trees exist in the rear yard. While it's unlikely these trees are remnant they do need require a further targeted assessment.	
Species observed on site	Native
Approx. age of larger trees on site	20-40 years
Approx. tree heights	10-20 metres
Significant trees	NA
Any habitat hollows observed	NA
Is further targeted assessment required on this site	Yes

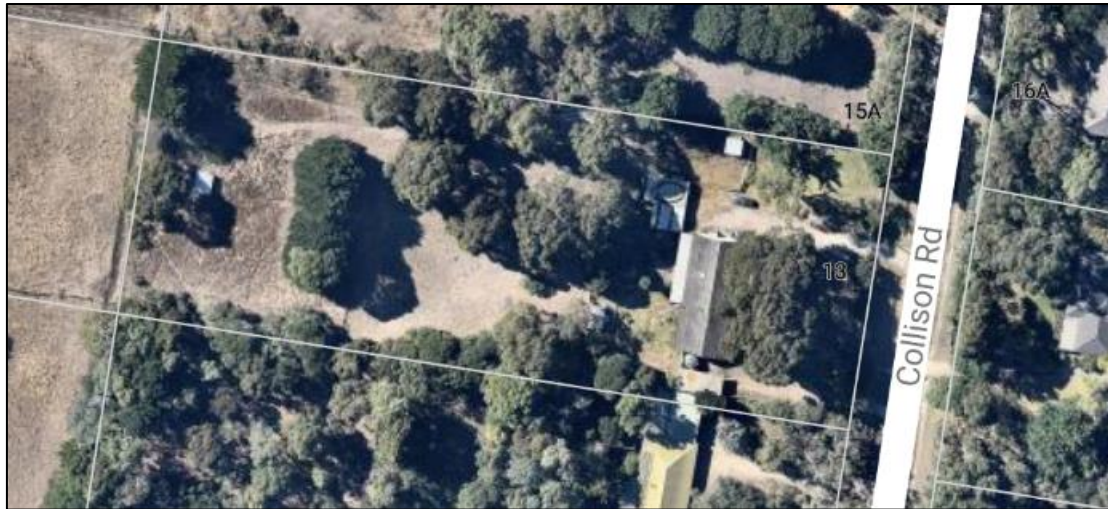
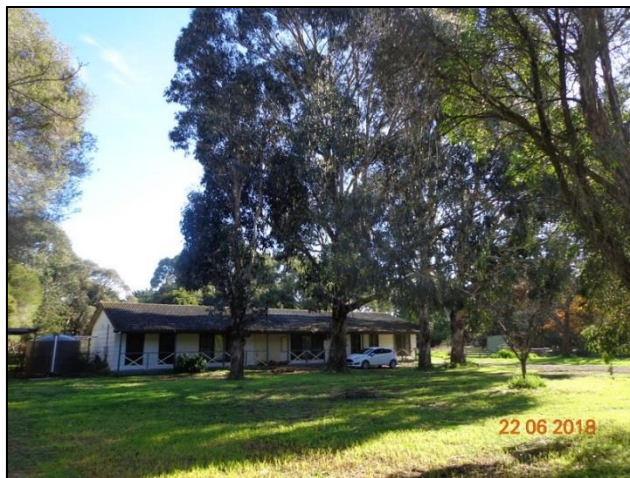
13 COLLISON ROAD, CRANBOURNE EAST

Site Description- Four native trees growing within the front setback are planted native Blue Gums. No remnant vegetation was observed on site.

Species observed on site	Native and exotic
Approx. age of larger trees on site	20-30 years
Approx. tree heights	15 metres
Significant trees	No
Any habitat hollows observed	No
Is further targeted assessment required on this site	No

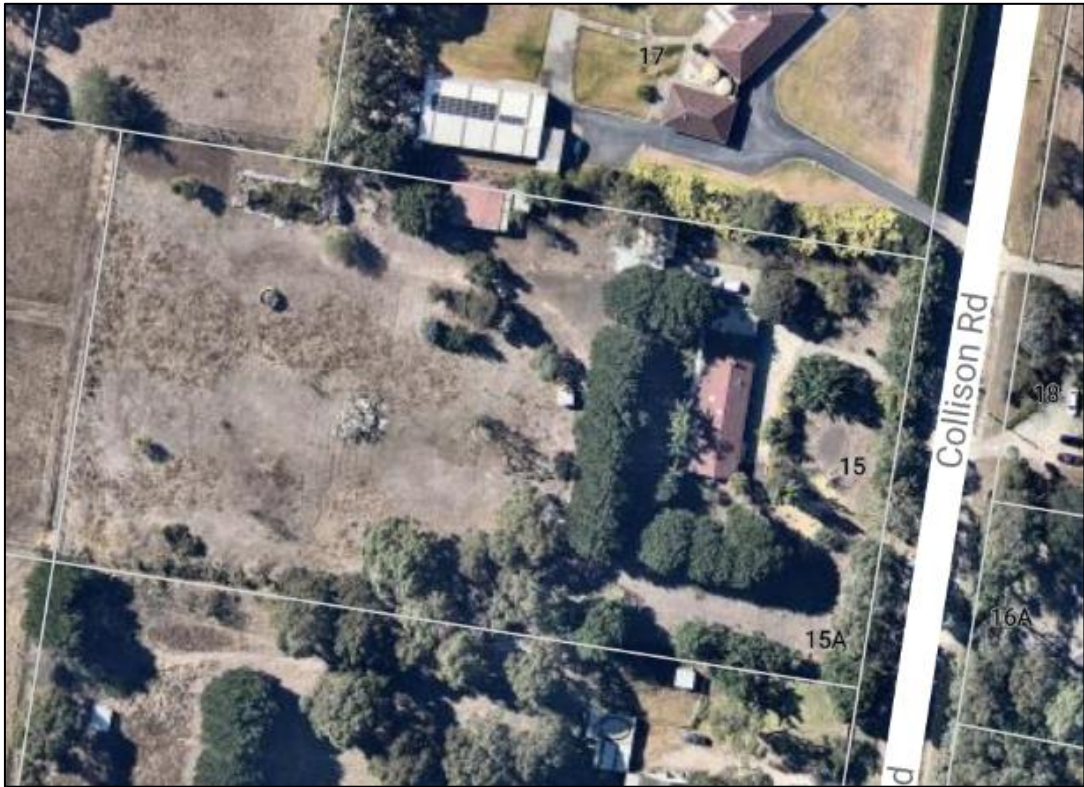
15 COLLISON ROAD, CRANBOURNE EAST

Site Description- Trees on site are a mix of planted native and exotic vegetation. No mature natives observed.	
Species observed on site	Native and exotic
Approx. age of larger trees on site	10 years
Approx. tree heights	NA
Significant trees	No
Any habitat hollows observed	No
Is further targeted assessment required on this site	No

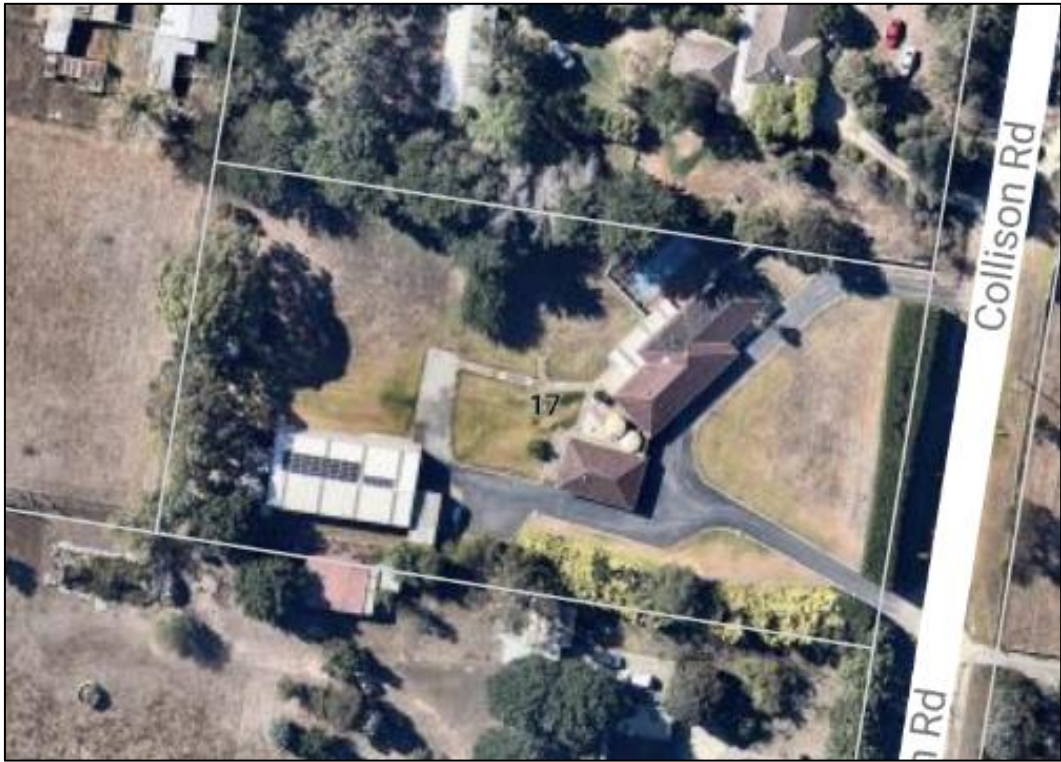
17 COLLISON ROAD, CRANBOURNE EAST

Site Description- Trees on site are a mix of planted native and exotic vegetation. No mature natives observed.	
Species observed on site	Native and exotic
Approx. age of larger trees on site	10 years
Approx. tree heights	NA
Significant trees	No
Any habitat hollows observed	No
Is further targeted assessment required on this site	No
